2.3 Building Damage

2.3.1 Overview

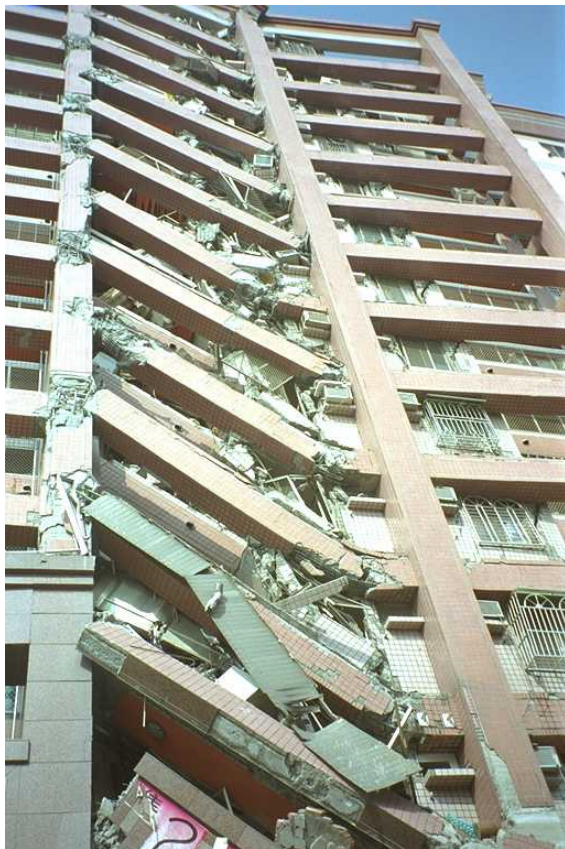
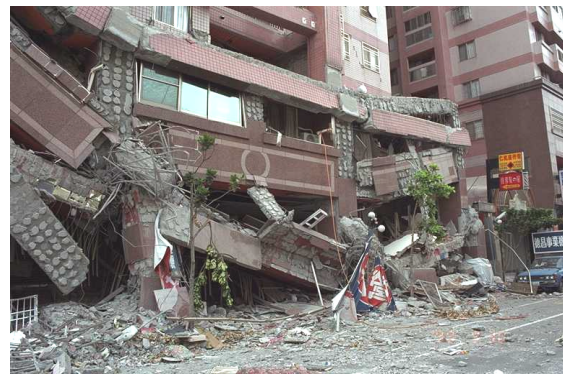
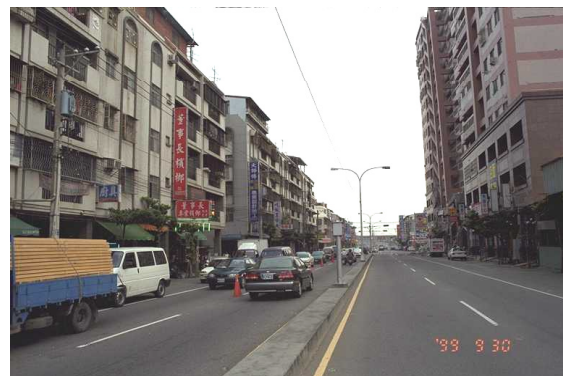
Photo 2.3.1. High-rise apartment building in Taichung.

Photo 2.3.1 shows a high-rise apartment building in Taichung City, whose first and second stories were crushed. Due to the uneven collapse of right and left parts of the building, the central part of the building sustained a displacement of one-story height. Damages to mid-height or low-rise buildings were not seen around this building.

(a) Damage situation from the 2nd floor to the top floor

(b) Collapse part of first and second stories
(Refer to color photo 5)

(c) Surrounding area. The collapsed building is in the right side back.

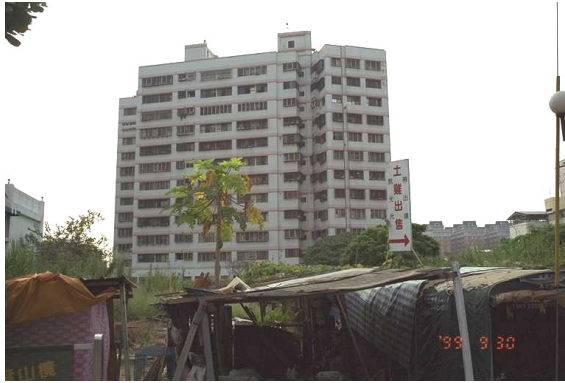
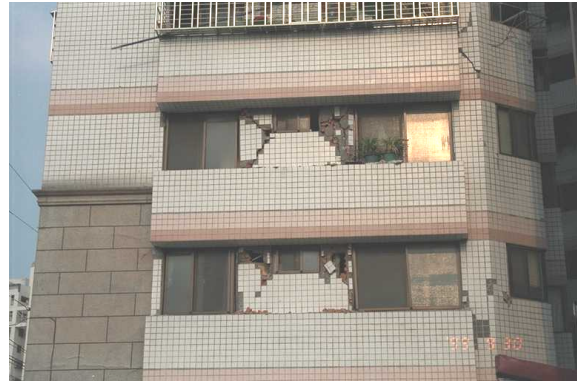
Photo 2.3.2. A damaged RC building in Taichung City.

Photo 2.3.2 shows the damage of a high-rise apartment building located near the north side of the building in Photo 2.3.1. Many cracks developed on the wall.

(b) Cracks on the wall

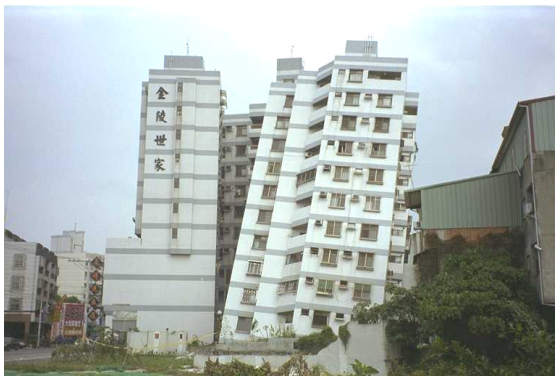
Photo 2.3.3. Collapse of RC buildings in Tali.

Photo 2.3.3 shows high-rise apartment buildings in Tali, located in the south of Taichung City. The building in Photo 2.3.3 (a) was inclined due to the collapse of the first story. The building in Photo 2.3.3 (b) is a collapsed high-rise apartment building, which is located in several hundreds meters away from the building in Photo (a). Among four similar buildings, only one of them collapsed. The same thing (one collapsed out of four similar buildings) also happened in the opposite side of the street. The mid-rise and low-rise buildings around these collapsed high-rise performed well against the strong shaking and no major damage was observed.

(a) Inclined apartment building
(Refer to color photo 6)

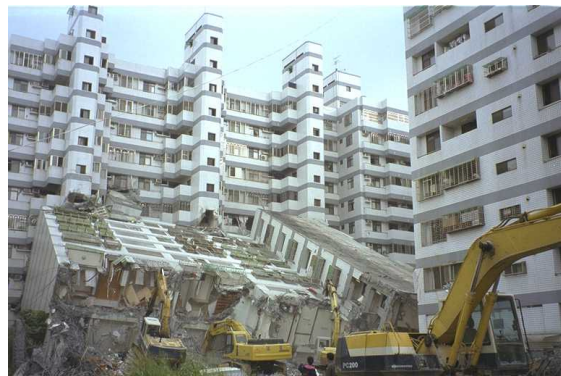
(b) Collapse of high-rise apartment building.
One building out of four similar buildings was collapsed.

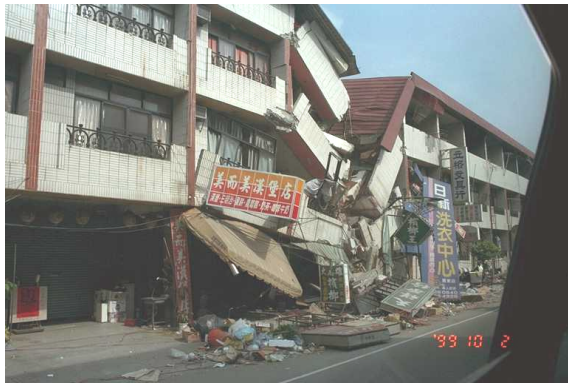
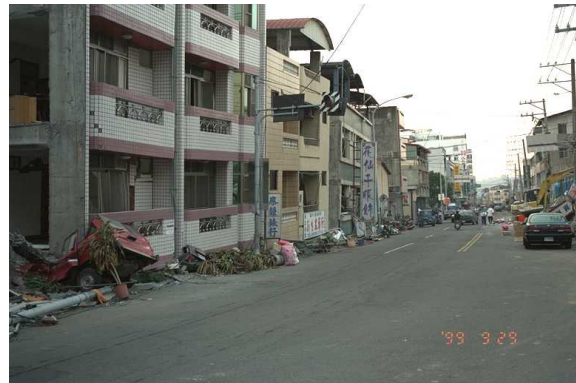
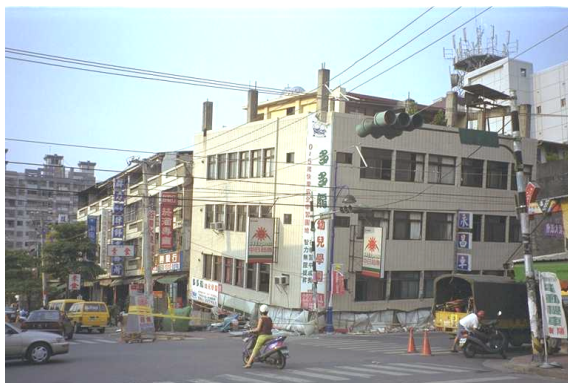
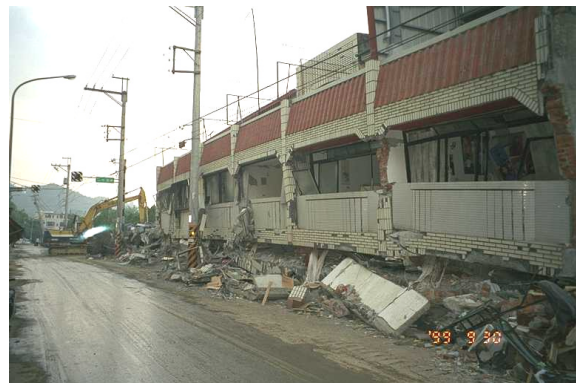
Photo 2.3.4 Collapse of 2-4-story RC buildings.

Setting back the 1st story of a building from the street and supporting the building with pillars in the front, the sidewalk of the street with roof becomes possible. This sort of buildings are quite common in Taiwan. RC buildings that suffered from damage due to the earthquake were mostly of this kind of structure. Because the front pillars of the buildings were destroyed, the building were inclined or collapsed.

Photo 2.3.4 shows the 2-4 storied RC buildings in (a) Fengyuan, (b) Tungshih, (c) Nantou City, (d) Chungliao. As seen in the photos, the first stories of these buildings were completely crushed. This type of damage was seen in the most of the affected areas.

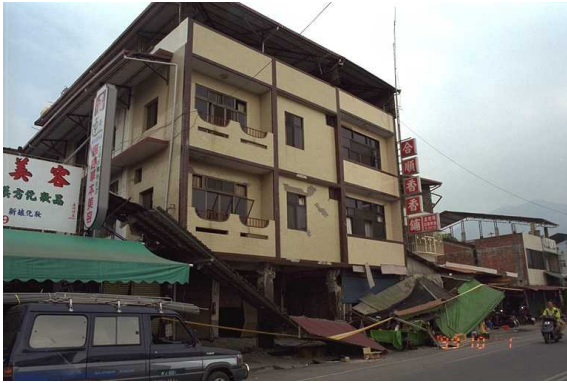
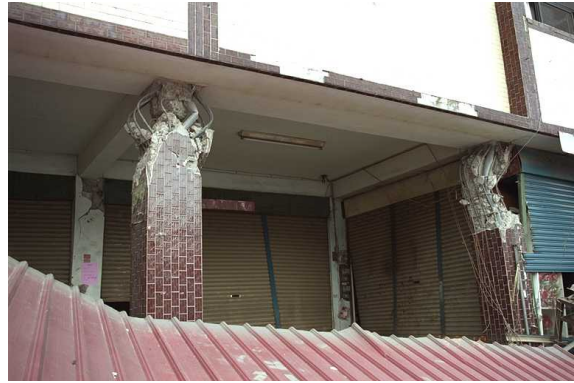
Photo 2.3.5 Damaged 3-story RC building in Puli.

Photo 2.3.5 shows the damage of a 3-storied RC building in Puli. A flexure failure was developed at the top of the pillars in the first story.

(b) Damaged pillar top of the first story

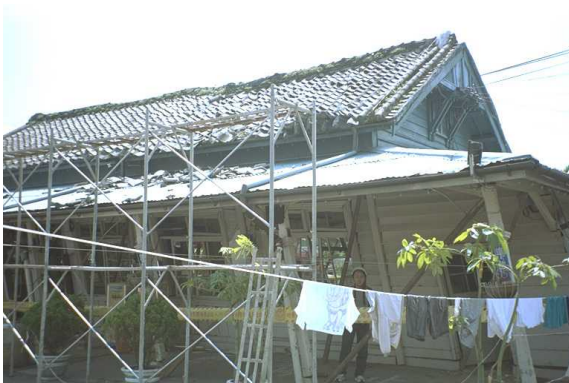
Photo 2.3.6 Damages of low-rise non-engineered buildings.

Photo 2.3.6 shows damage of low-rise non-engineered buildings. In the hard-hit areas, collapses of wooden and earthen buildings/walls were seen as well as damage to engineered buildings.

(a) Damage of Chi-Chi Station
(Refer to color photo 11)

The building of the station (Photo 2.3.6 (a)) was made by wood-frame with roof-tile, a typical Japanese style construction, since it was built during the Japan regime. The station seems to be a landmark of the town. When we visited ten days after the earthquake, restoration of the damaged roof started by the residents.

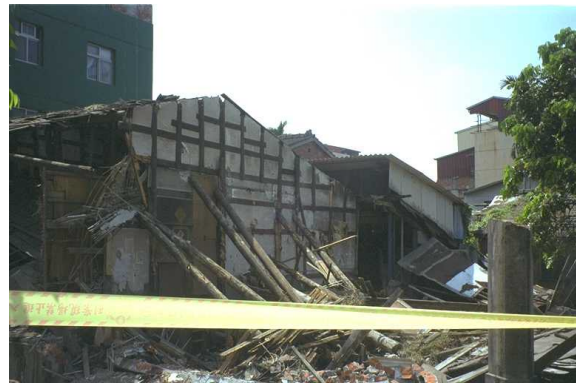
(b) Collapse of a building with earthen wall in Chi-Chi

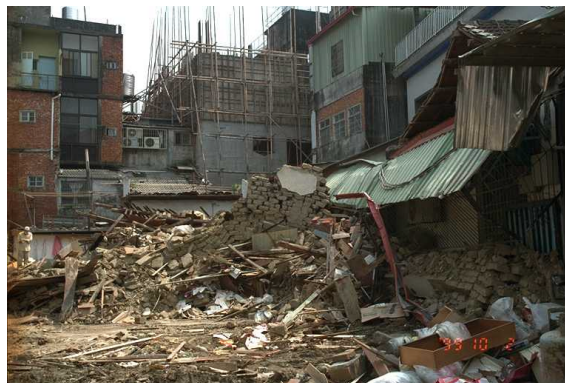
(c) Collapse of an earthen brick building in Tungshih

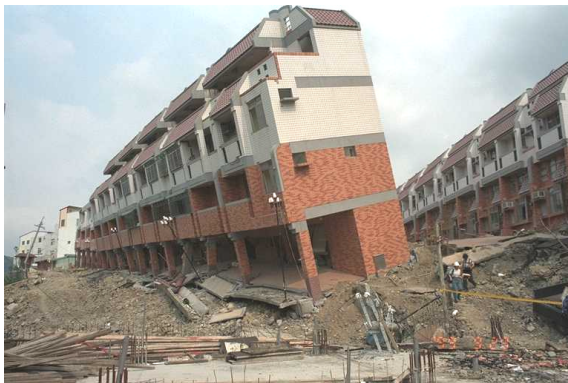
Photo 2.3.7. Damaged and undamaged 4-story RC buildings in Fengyuan.

Photo 2.3.7 (a) shows an inclined building in Fengyuan. The surface faulting runs just beneath the building, and hence, the building was inclined due to the displacement. A similar looking building located in scores of meters away from the rupture was intact as seen in Photo 2.3.7 (b).

(a) Inclined building just on the fault rupture
(Refer to color photo 9)

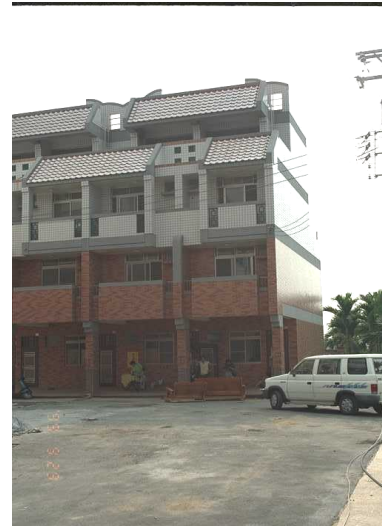
(b) An intact building with the similar structure as (a) located near the fault

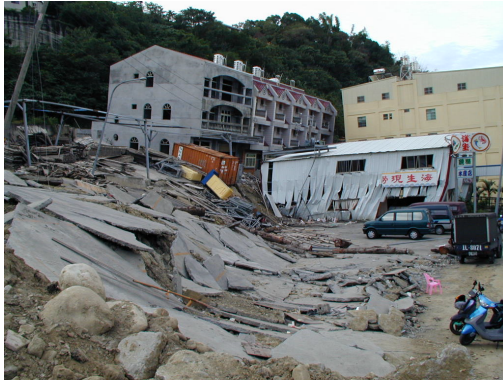
Photo 2.3.8. Damaged and undamaged buildings in Fengyuan.

Photo 2.3.8 shows buildings in Funyuen along the fault rupture. Although the buildings in Photo (a) standing on the fault sustained apparent damage, no clear damage can be seen the buildings in Photo (b), which are in about ten meters from the fault.

(a) Building on the fault

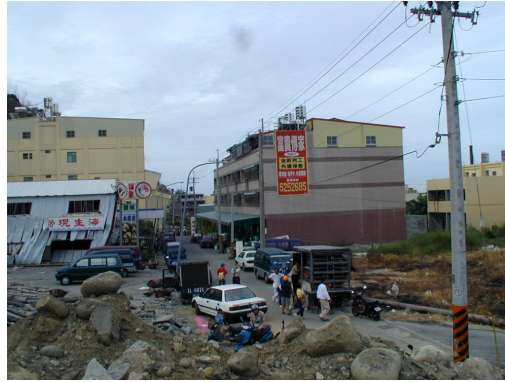
(b) Building not on the fault

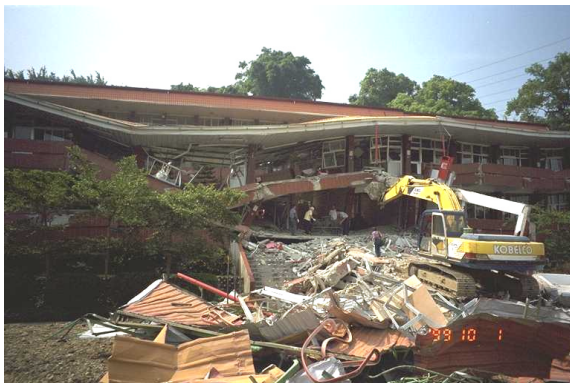
Photo 2.3.9 Collapsed buildings in Wufeng due to the surface faulting.

Photo 2.3.9 shows damage to RC buildings in Wufeng a school building in Photo (a) was collapsed due to the fault displacement of 1m, passing underneath the building. The building in Photo (b) sustained severe damage in the middle part because the fault rupture ran across the building.

(a) School building
(Refer to color photo 10)

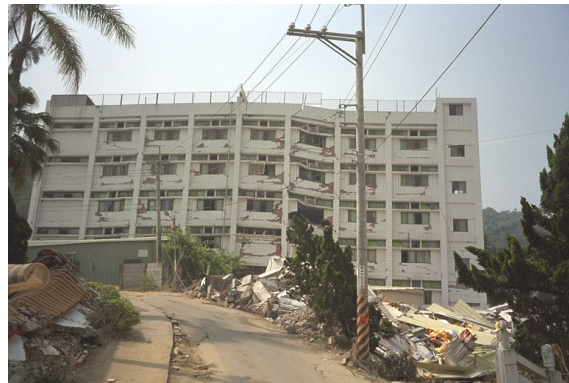
(b) A 5 story RC building

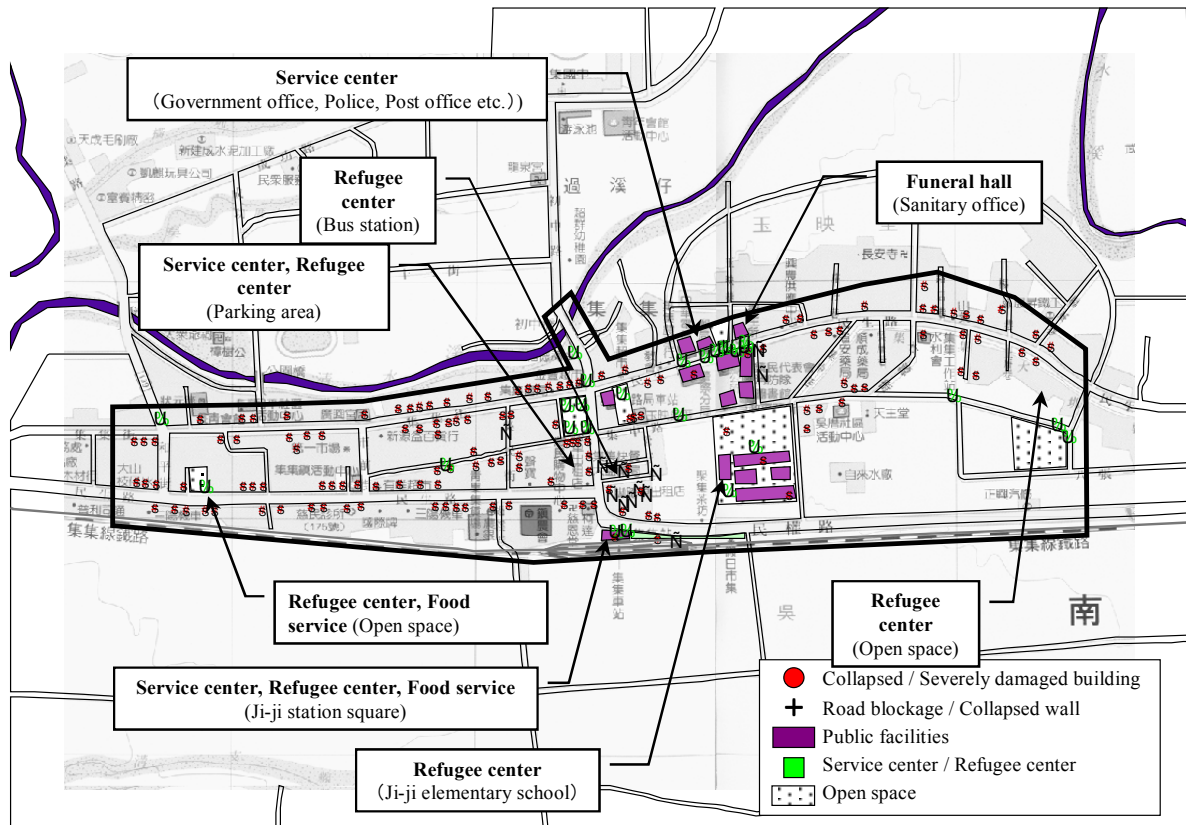
Figure 2.3.2. Damage data map of Chi-Chi based on the field survey.

The field survey by an EDM team was carried out in the central part of Chi-Chi, near the railway station. A GIS map shown in Fig. 2.3.2 was developed using the data collected during the field survey and the video pictures and photographs taken the survey team. Building damages along the main streets are plotted on the map. The damage in Chi-Chi was much more extensive than other municipalities near the fault line. The buildings in Chi-Chi were mostly one or two-storied wooden houses and most of them were collapsed or severely damaged due to the earthquake. Some engineered buildings also sustained severe damage, e.g. collapse of soft first story. In the slabs and walls of some collapsed buildings, gallon-size oil cans and polyvinyl chloride pipes were observed, which might be partially responsible for the collapse.
