## 2.5 Liquefaction

### 2.5.1 Outline of Surveys

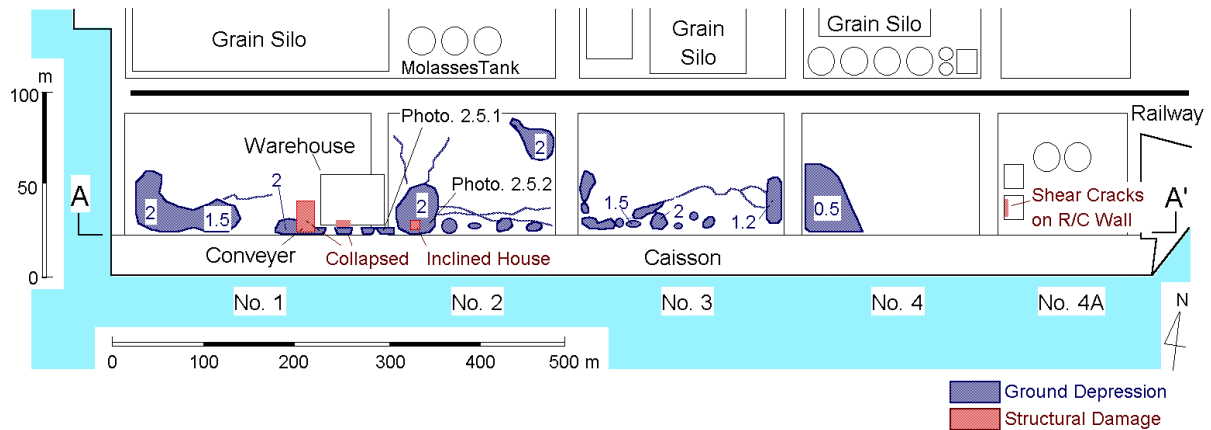
Ground failures and structural damage observed in the investigated area are concluded in Figure 2.5.2. The backfills subsided due to seaward movements and inclinations of the caissons (Photo 2.5.1), and length and width of the subsided area were about 800m and 40m, respectively. Most of the caissons were damaged slightly or not. Figures 2.5.3 and 2.5.4 show horizontal seaward displacements of the caissons (Chen and Hwang, 2000) and settlements of backfills, respectively, which were measured at several spots in the wharfs after the earthquake. Maximum values of inclinations and horizontal displacements of the caissons were about 1-3 degree and 1.7m, respectively. Maximum settlement of backfills was about 1.4m. Comparing Figure 2.5.3 with Figure 2.5.4, it is indicated that the larger horizontal displacements of the caissons, the larger become settlements of backfills. Besides, many ground depressions were observed in the subsided area (Photo 2.5.2). Maximum length, width, and depth of the depressions could be 15m, 15m, and 2m, respectively. Soils observed in these ground depressions consisted mainly of fine sands and gravels with a diameter of 10-20cm. Due to the ground depressions, one belt conveyer facility and one reinforced concrete (R/C) framed warehouse were collapsed (Photos 2.5.3 and 2.5.4), and their locations are marked on Figure 2.5.2. Furthermore, remarks of sand boils were observed at several spots mainly around the ground depressions and the vertical gaps occurred between the caissons and backfills. Based on the above observations, it is indicated that these ground failures could be caused

Figure 2.5.2. Schematic map showing damage to structures and soils at North terminal in Taichung Harbor. Numbers in the figure are maximum settlements of ground depressions (in m).

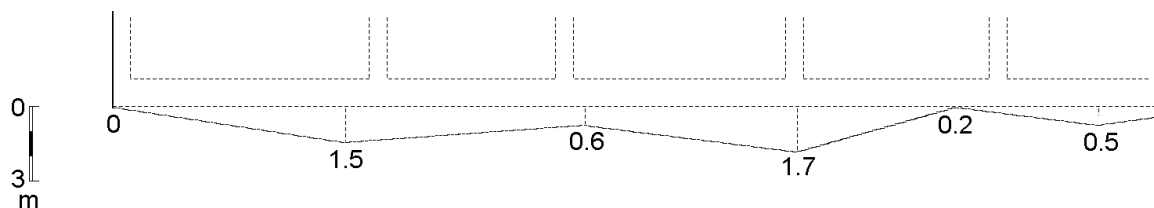
Figure 2.5.3. Rough sketch of horizontal seaward displacements of caissons (in m, Chen and Hwang, 2000).

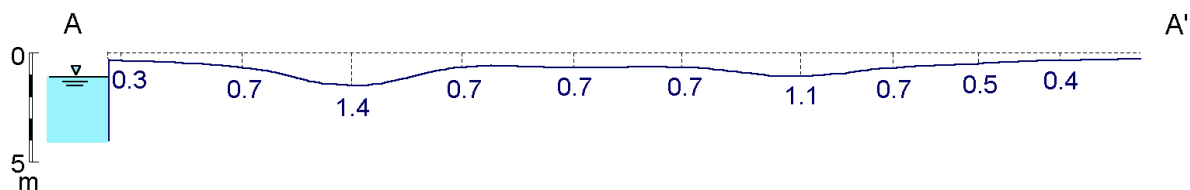
Figure 2.5.4. Rough sketch of maximum settlements of backfills along the line A-A' in Figure 2.5.2 (in m).

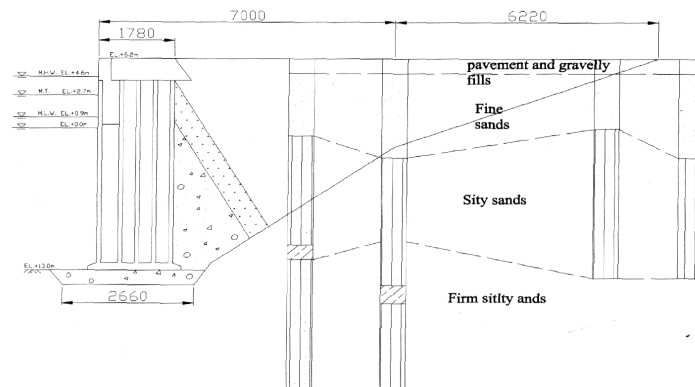
Figure 2.5.5 shows a schematic section of subsurface soils and a caisson near the No.3 wharf in North terminal, which is based on the results of geological boring logs performed after the earthquake (Chen and Hwang, 2000). The original seabed consists mainly of sands with loose to medium dense, interbedded with several thin layers of clayey silt or silty clay. SPT-N values of the seabed range over about 20. Above the original seabed, sands dredged from the navigation channel and nearby areas are filled hydraulically to the present ground level. The hydraulic sand fills consist mainly of two layers, which are fine sands and silty sands, respectively. The both layers are quite loose, and their SPT-N values range from 5 to 14. The ground surface was paved with gravelly soils of thickness 30cm. Judging from these information, it is suggested that the fine sand layers up to a depth of 6m could be liquefied during the earthquake. Besides, it is also suggested that the gravels observed in the ground depressions stated above might be used for the pavement of ground surface.

Figure 2.5.5. Schematic section of the No. 3 wharf in North terminal (Chen and Hwang, 2000).

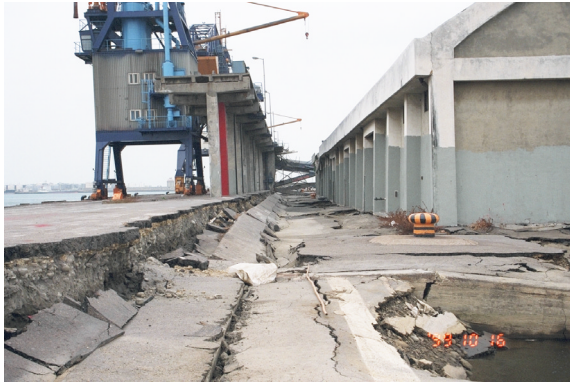
Photo 2.5.1. Settlement of backfills at North terminal in Taichung Harbor.

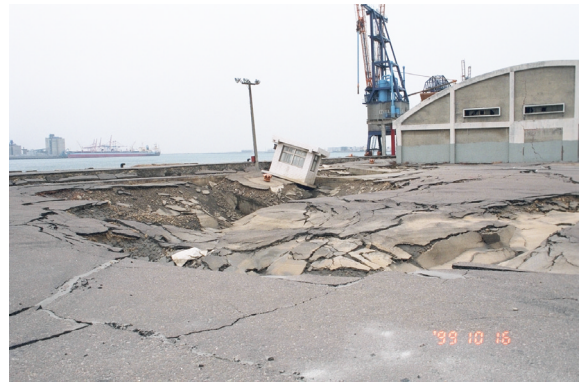
Photo 2.5.2. Ground depressions at North terminal in Taichung Harbor (Refer to color photo 18).

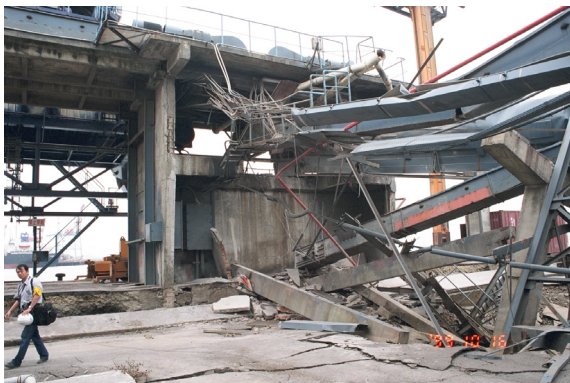
Photo 2.5.3. Collapsed belt conveyer facility at North terminal in Taichung Harbor.

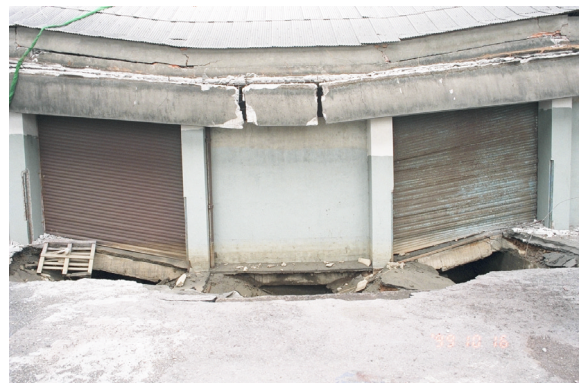
Photo 2.5.4. Collapsed R/C warehouse at North terminal in Taichung Harbor.

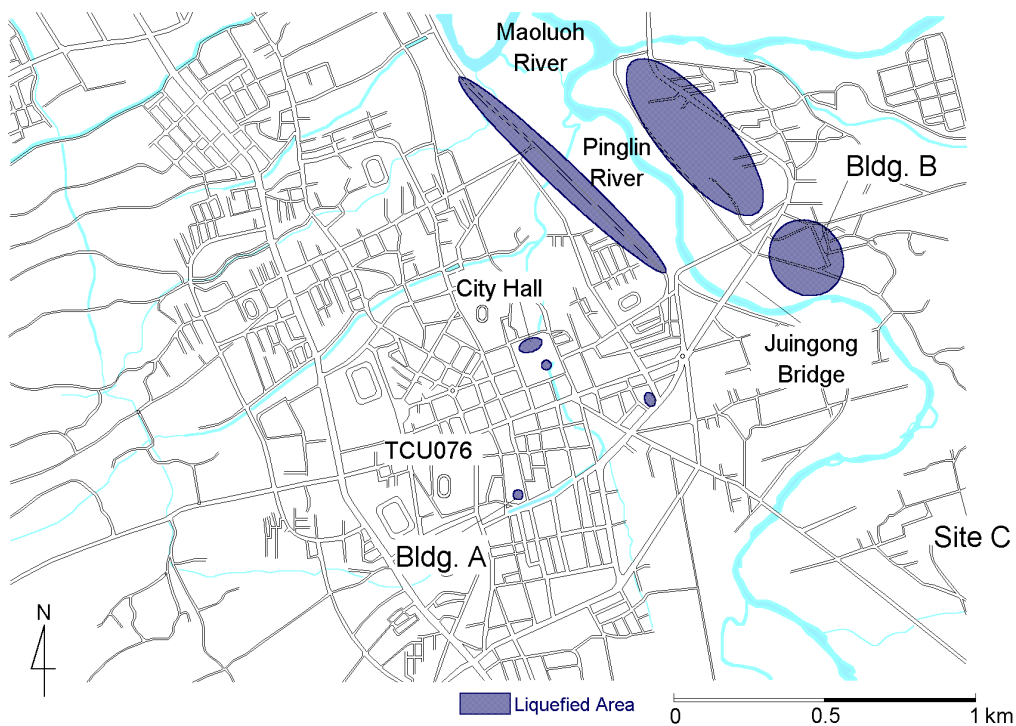
Figure 2.5.7 shows a schematic map of central part of Nantou city. In this area, remarkable ground failures were observed at several local districts shown in the figure. For example, a five-storied R/C framed building (hereby called Building A shown in Figure 2.5.7) inclined 4 degree to the southern direction without any structural damage on the upper structure (Photo 2.5.5). In the park near the city hall shown in Figure 2.5.7, small vertical gaps between building and ground were observed. The embankments of Pinglin River settled by about 1m. Around Juigong Bridge on Pinglin River, a 16-storied R/C framed building (hereby called Building B shown in Figure 2.5.7) settled by about 70cm without any inclination. Some shear cracks were observed on the walls of Building B, and those might be due to differential settlements of the building. Except the above damage, however, any damage to the superstructure material of Building B could not be observed (Photo 2.5.6). On the basement floor of Building B, remarks of sand boils were observed (Photo 2.5.7), indicating that the subsurface soils under the building could be liquefied during the earthquake.

Figure 2.5.7. Schematic map showing liquefied areas in Nantou city.

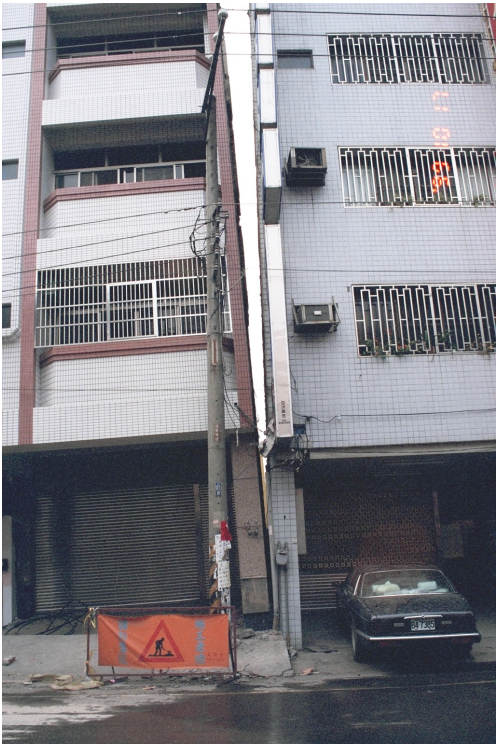
Photo 2.5.5. Inclination of Building A in Nantou city.

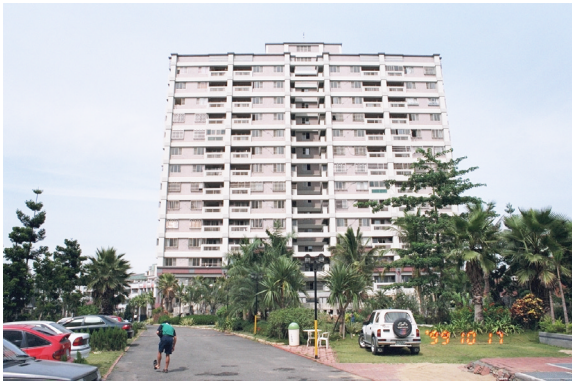
Photo 2.5.6. Subsided Building B in Nantou city.

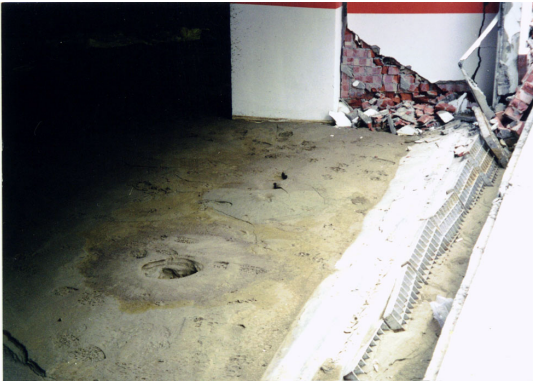
Photo 2.5.7. Remarks of sand boils at basement floor of Building B in Nantou city (Provided by Mr. Hitoshi Kumagai).

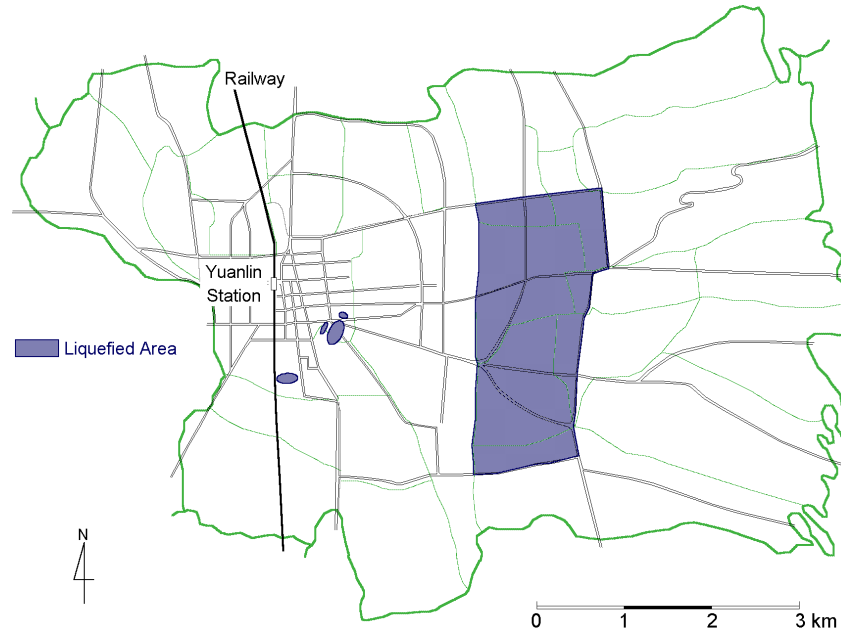
Figure 2.5.10 is a map showing liquefied areas in Yuanlin district, which have been reported elsewhere (According to comments of the district office). In the central area shaded in the figure, however, ground failures could be confirmed at several narrow sites only, in fact. For instance, Figure 2.5.11 shows a rough sketch of damage distribution in a small community, which is located in the shaded area shown in Figure 2.5.10. Several

Figure 2.5.10. Schematic map showing liquefied areas in Yuanlin district.

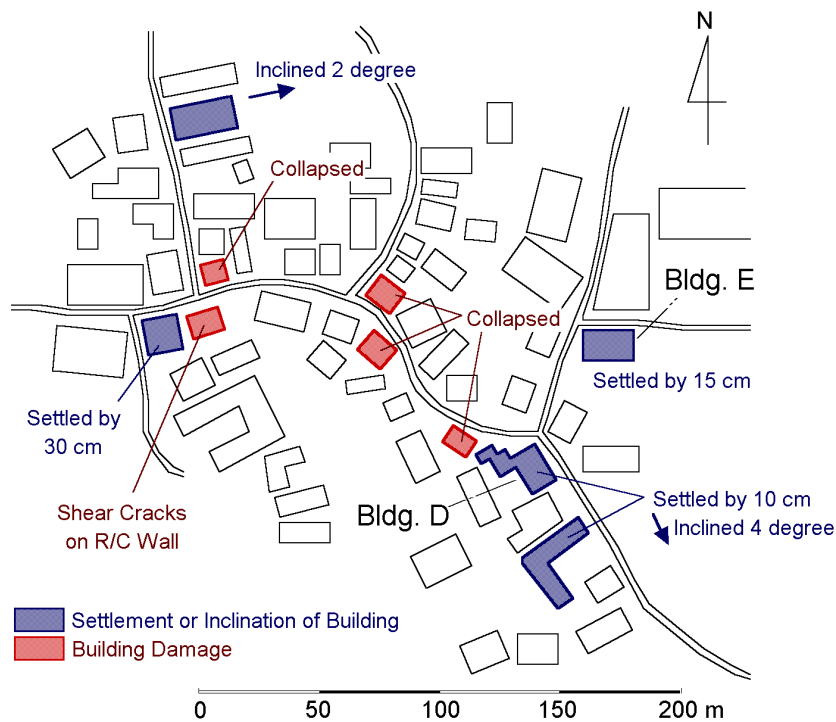
Figure 2.5.11. Schematic map showing damage to structures and soils in a small community, located in the shaded area in Figure 2.5.10.

R/C buildings, which were under four-storied, were collapsed in the area. On the other hand, several R/C buildings, which were over four-storied, settled and/or inclined without any damage to their upper structures. In Figure 2.5.11, it is suggested that these buildings and soil damage could occur at some limited local spots. Maximum values of settlements and inclinations of the buildings were about 30cm and 4 degree (Photo 2.5.8, Building D shown in Figure 2.5.11), respectively. Boiled sands (but they were silty) due to liquefaction were observed at several settled buildings (for example, Photo 2.5.9, Building E shown in Figure 2.5.11). Besides, several depressions of paddy fields were observed in this area, because there were in cultivated lands.

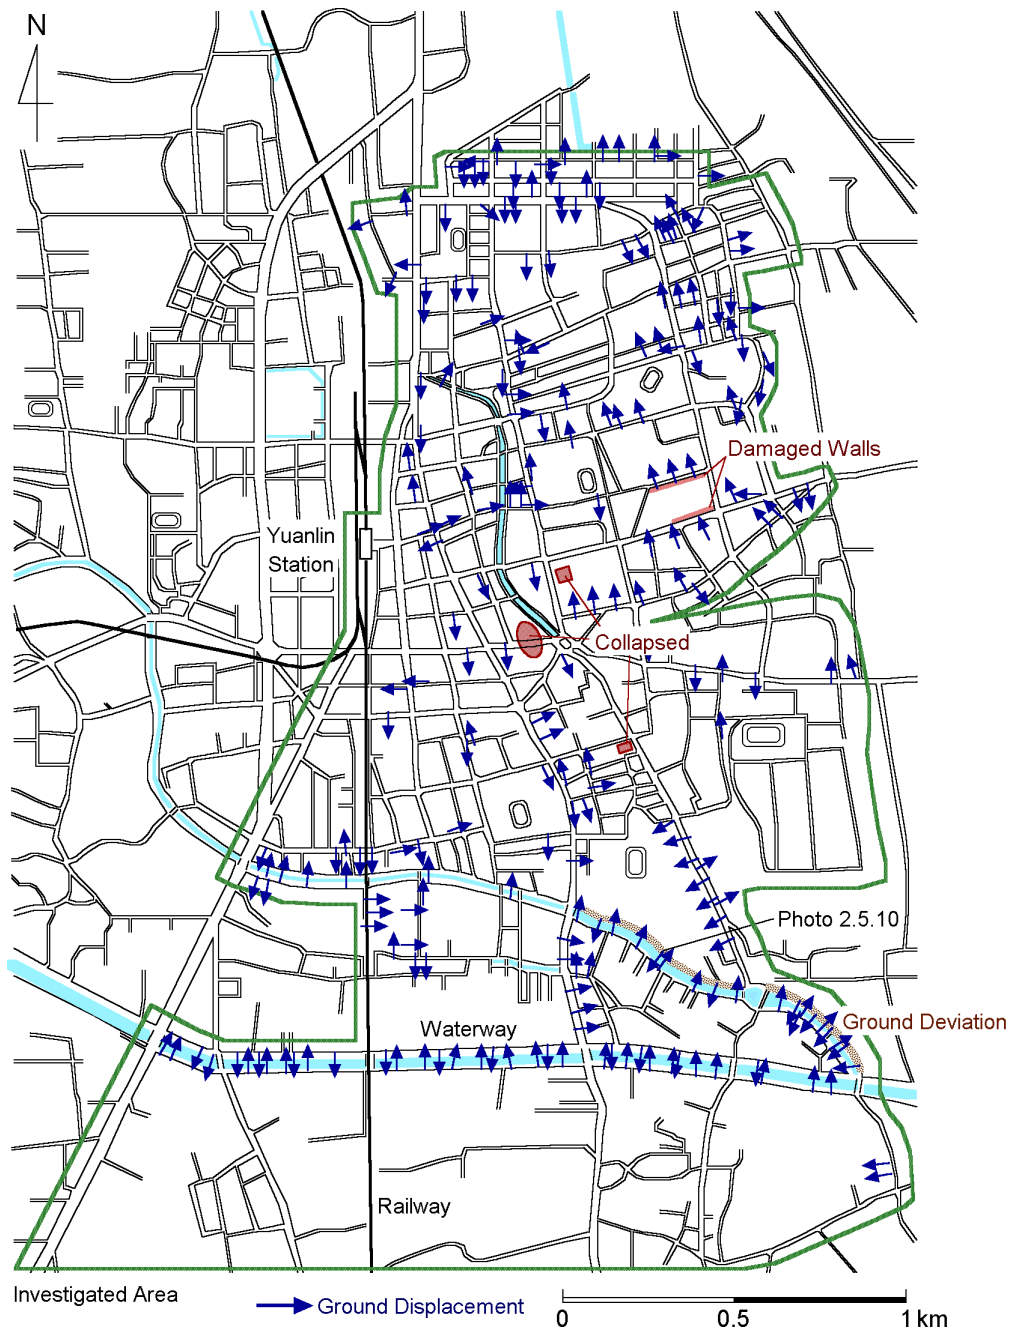
Figure 2.5.12. Schematic map showing structural damage and ground displacements around Yuanlin station.

Around the station of Yuanlin, it was hard to find ground failures, but many inclined telegraph poles were found easily. The telegraph pole could incline to the opposite direction of ground displacement, when subsurface soils moved or flowed laterally during or after earthquakes. Therefore, the inclinations of telegraph poles in this area were recorded, and the opposite directions of the inclinations (maybe the directions of ground displacements) were marked on the map as shown in Figure 2.5.12. The investigated area is also shown in the figure. It is suggested that the embankments at the both side of the waterway could move or deviate to the waterway (Photo 2.5.10). Maximum horizontal displacements of ground to the waterway were about 1m. On the other hand, at the sites far from the waterway, the directions of ground displacements were various spatially, therefore, it was difficult to find out any rule nature. Based on the above observations, it is suggested that subsurface soils in the area could move or deviate to various directions during or after the earthquake.

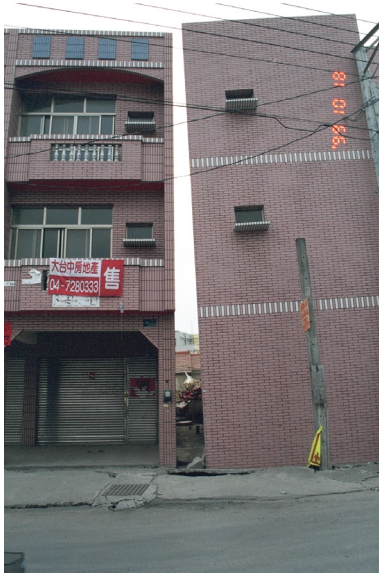
Photo 2.5.8. Inclination of Building D in Yuanlin district (Refer to color photo 12).

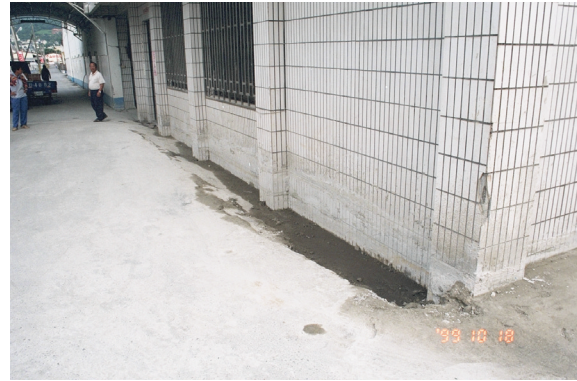
Photo 2.5.9. Settlement of Building E in Yuanlin district.

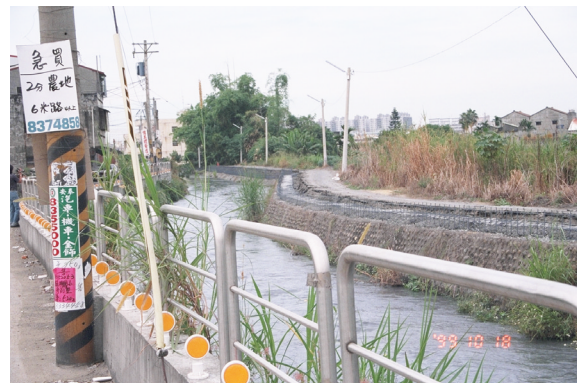
Photo 2.5.10. Inclination of telegraph poles and ground deviations at waterway in Yuanlin district (Refer to color photo 13).
