Chapter 2. Earthquake and Damage

2.2 Building Damage

2.3 Ground Failure

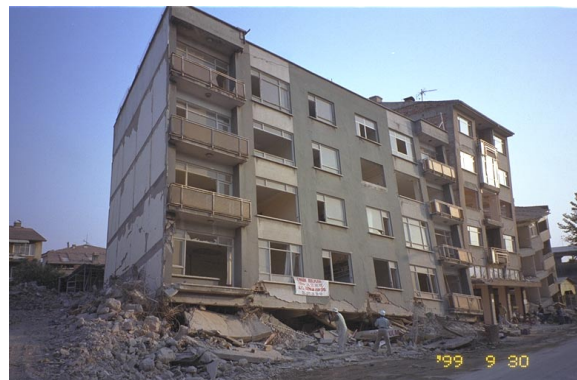
Photo 2.2.2. Residence building collapsed at first story in Adapazari (Refer to color Photo 2).

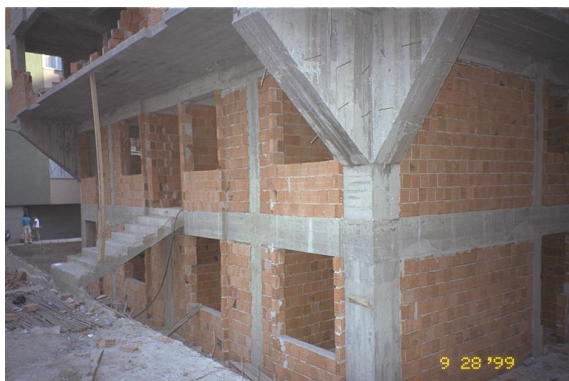
Photo 2.2.3. Set back lower story of residence building in Avcilar.

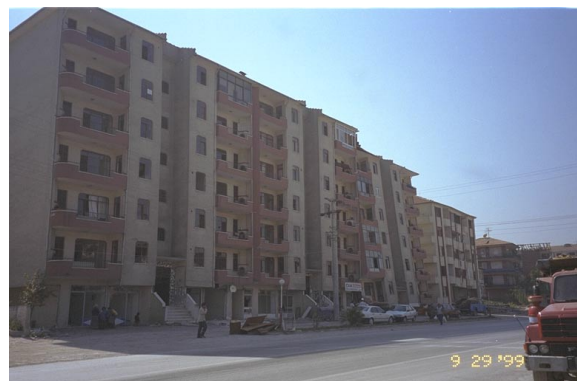
Photo 2.2.4. Commercial buildings close each other in Golcuk.

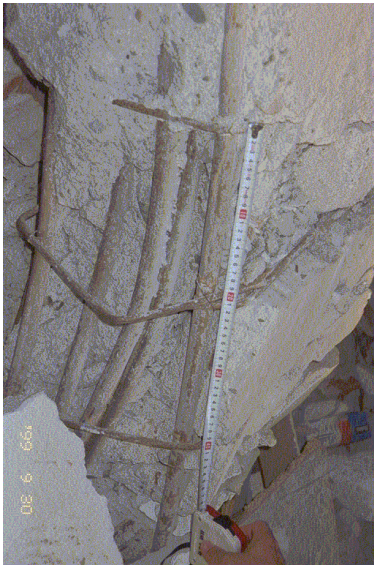
Photo 2.2.7. Reinforcement bar in collapsed column of building, Adapazari.

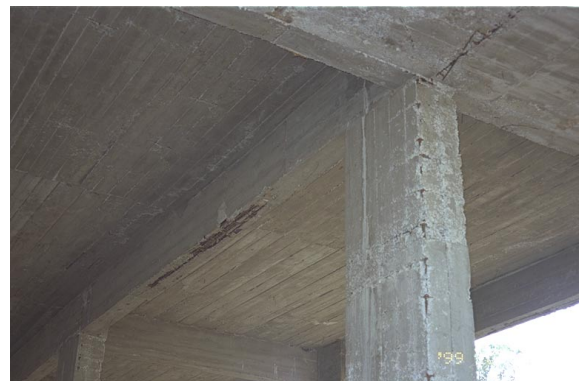
Hollow clay block usually used as material for infill wall. Recently, formed concrete block become more common. By the observation on concrete of collapsed members, quality of concrete seems to be relatively poor. A majority of concrete is mixed on construction site by the use of a concrete mixer machine. Ready-mixed concrete is not common for residence buildings. We measured the compressive strength of concrete, in four residence buildings constructed in Golcuk, Sapanca and Adapazari (Photo 2.2.9). Schmidt Hammer (the measuring capacity is 10 to 70 MPa) was used to measure the compressive strength. The test results are shown in Table 2.2.1. Generally, estimated value from the Schmidt Hammer test greatly depends on the assumed age of the material. In the reconnaissance, we could not exactly check the year those buildings were built. Therefore, the values are indicated for surmised age of material. Assumed strength from the tests were between 12 and 22 MPa. Details of the reinforcement are relatively poor. By the investigation, observed details of reinforcement were summarized as follows, longitudinal reinforcement with 18 plain bar, usage of 90 degrees hooks, insufficient splice length, transverse hoops typically spaced at 25 to 30 cm, lack of concrete confinement in the columns and at the beam-column joints, cover concrete less than 10mm (Photo 2.2.10), etc.

Photo 2.2.10. Exposed reinforcing bars of column and beam, Sapanca.

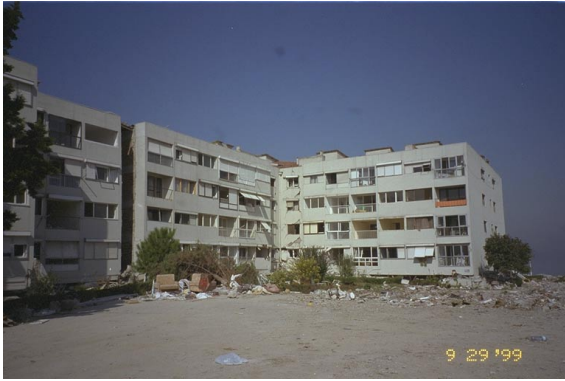
Photo 2.2.11. Collapsed first story of residence building in Aydıncık.

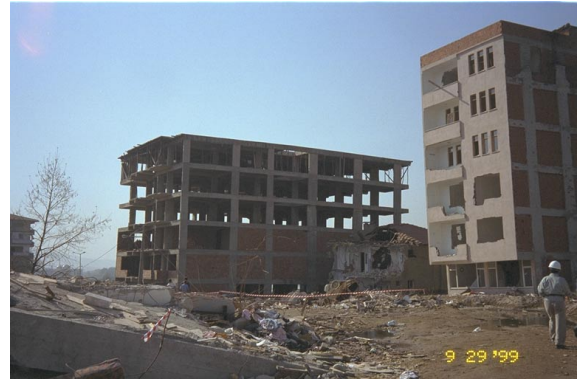
Photo 2.2.12. Submerged buildings and ground depression in Gölçük.

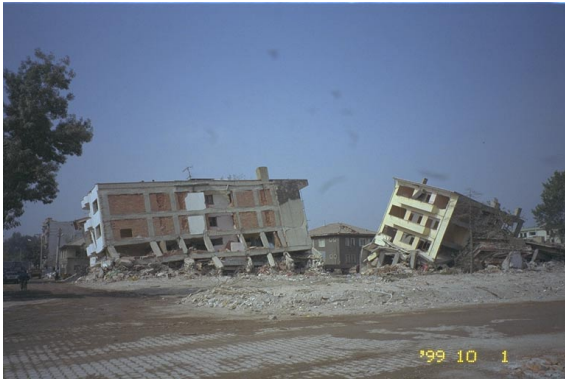
Photo 2.2.13. Collapsed buildings caused by ground failures in Adapazarı (Refer to color Photo 4).

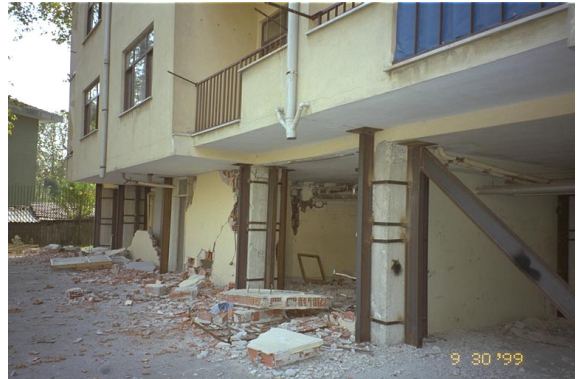
Photo 2.2.14. Damaged columns and walls in piloti of residence building, Yarımca (Refer to color Photo 5).

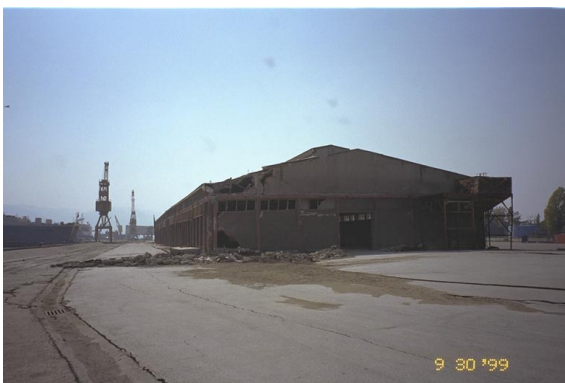
Photo 2.2.15. Warehouse damaged by crane fall, Derince Port.

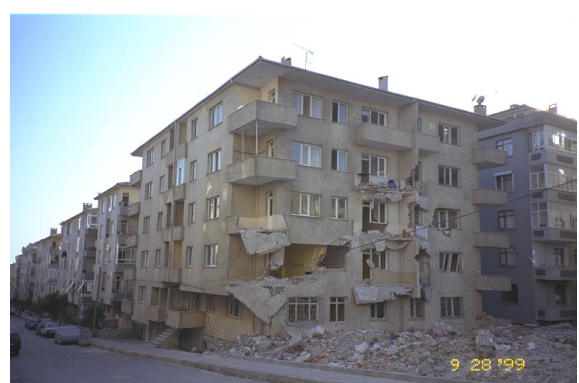
Photo 2.2.16. Residence buildings next to collapsed building in Avcılar.

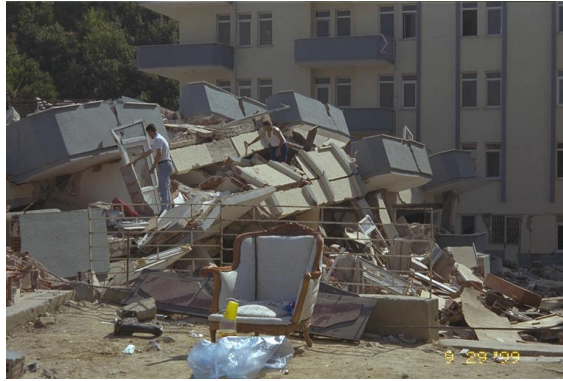
As remarkably observed in Golcuk and Adapazari, spatial distribution of building damage was supposed to be affected by the ground structure and liquefaction. A large number of buildings suffered serious damage that was constructed in improper site, such as on active faults and in areas of high liquefaction potential. Generally speaking, however, the high damage ratio might be due to the structural features mentioned above, rather than the strong motion characteristics. A majority of the residence building collapses in soft first story (Photo 2.2.2). To give considerable factors of the cause, following factors seem to be the major factor of collapse process: 1) soft story without seismic resistant wall; 2) poor confinement reinforcement in beam-column joints; and 3) heavy load against weak first story. Generally, most of residence building perform alterations of adding upper floors without strengthen the existing structure. Another typical pattern of whole building collapse is “pancake collapse”. The majority of the collapse seems to be due to the failure of a certain story, and that caused layer collapse of other stories (Photo 2.2.17).

Photo 2.2.17. Pancake collapse of residence building, Yalova-Golcuk (Refer to color Photo 6).

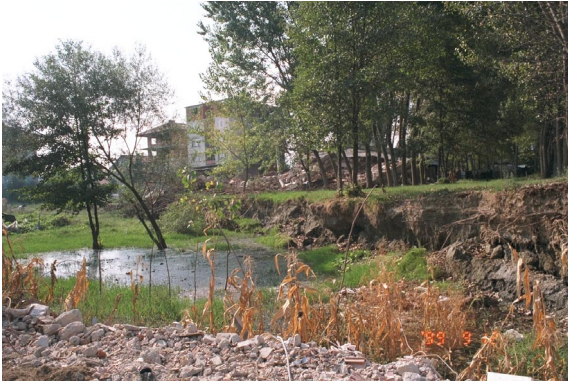
Photo 2.3.1. Fault scarp in Kavakli district, Golcuk, Sep. 1999 (Refer to color Photo 7).

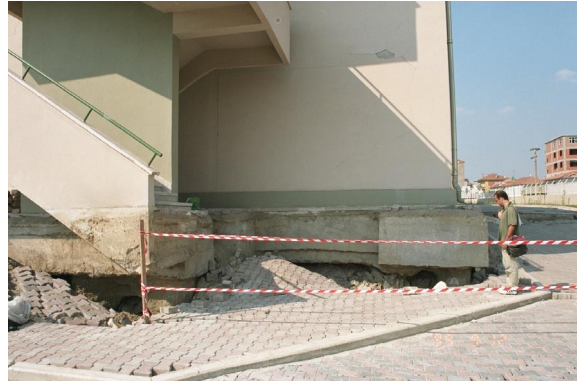
In this district, a gymnasium with pile-foundation was just located on and was damaged due to the fault scarp (Figure 2.3.1). The pile-foundation of the building was exposed due to vertical gap of the fault scarp (Photo 2.3.2). Photo 2.3.3 shows the head part of the exposed piles arranged at the northeast corner of the building foundation. In the photo, the head part of the left-side pile was damaged, and its failure mode could seem to be shear one. These observations suggest that the failure on the pile-head could be caused due to horizontal gap of the fault scarp. On the other hand, the upper structure of the building had less serious damage, except shear cracks on three columns of the building. Namely, this gymnasium on the fault scarp was caused severe damage

Photo 2.3.2. Exposed pile-foundation of a gymnasium in Kavakli, Golcuk, Sep. 1999 (Refer to color Photo 8).

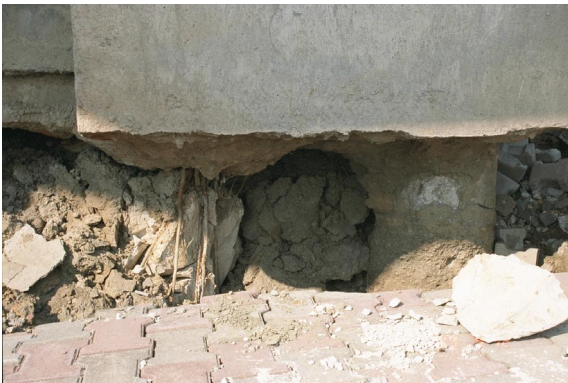
Photo 2.3.3. Damaged pile-head of a gymnasium in Kavakli district, Golcuk, Sep. 1999 (Refer to color Photo 9).

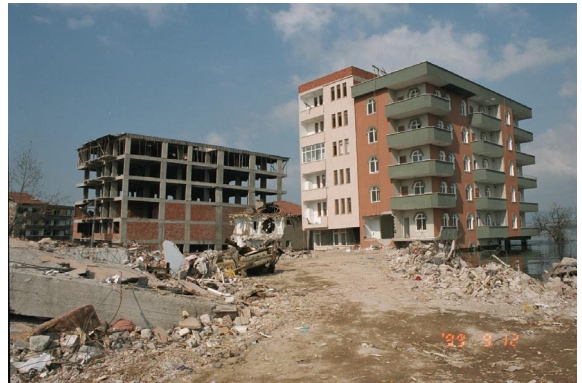
Photo 2.3.4. Depression of ground under buildings in Kavakli, Golcuk, Sep. 1999 (Refer to color Photo 10).

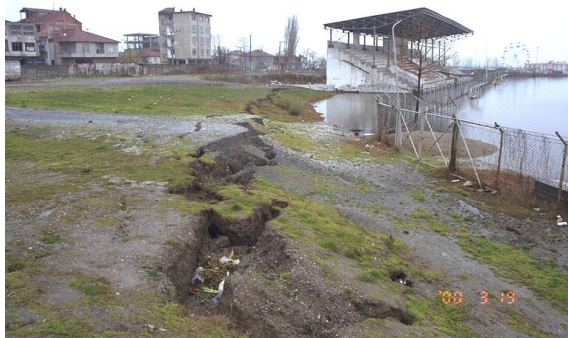
After seven months, the extent of the submerged area was smaller than that in Sep. 1999. The location of waterfront moved seaward as shown in Figure 2.3.1. The eastern area of the field in the stadium was not submerged; on the other hand, the western area was submerged as shown in Photo 2.3.5. Moreover, the eastern residential area of the stadium, which was submerged in Sep. 1999, was almost dry. According to comments of local residents, the waterfront line moved seaward about one month ago.

Photo 2.3.5. Fault rupture and submerged field in Kavakli district, Golcuk, Mar. 2000 (Refer to color Photo 11).

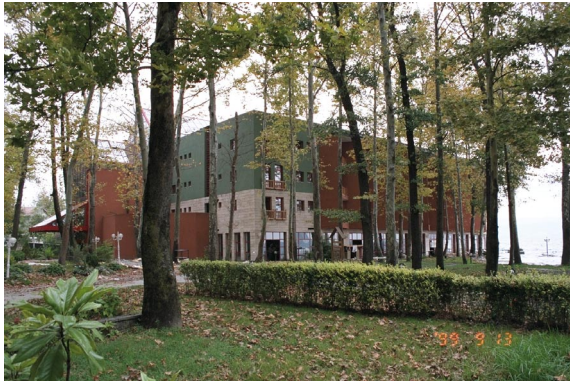
In the vicinity of the lakefront, several settled and/or inclined buildings could be observed. For instance, the building (hotel) shown in Figure 2.3.2 subsided and inclined to the lakeside and its 1st floor was submerged (Photos 2.3.6 and 2.3.7, on Sep. 1999). This building consists of two-ridges of annex and old mansions, and a roofed passage between the both mansions fell down during or after the earthquake. Except the above damage, any damage could not be observed in the superstructure material of this building.

Photo 2.3.6. Submerged hotel located on the shore of Lake Sapanca, Sep. 1999 (Refer to color Photo 13).

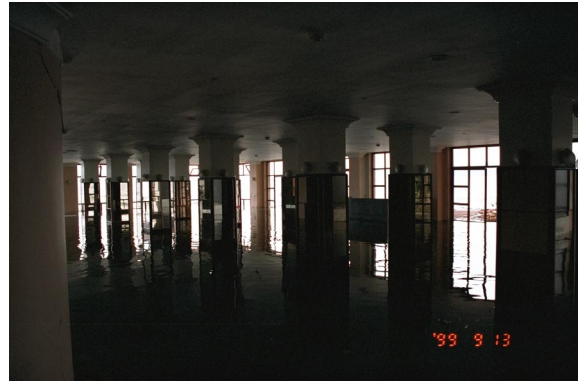
Photo 2.3.7. Submerged 1st floor of Sapanca Hotel, Sep. 1999 (Refer to color Photo 14).

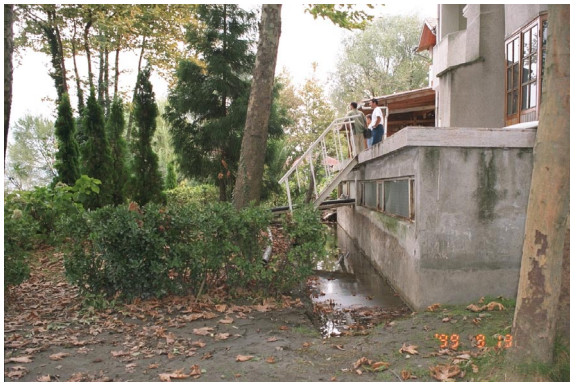
Photo 2.3.8 shows a relative displacement between ground and building, on Sep. 1999, which was a residential house with a mat type foundation. This residential house was located to the shores of Lake Sapanca as shown in Figure 2.3.2. Maximum horizontal gap occurred between ground and the building was about 2m wide. In Photo 2.3.8, some boundaries where ground had touched the building before the earthquake could be observed on the wall of the building, and no damage could be found in the upper structure. These suggest that ground might move to the lakeside (left-side in Photo 2.3.8) and subsided during or after the earthquake and that this relative displacement might be caused due to both or either of liquefaction and lateral spreading of the ground.

Photo 2.3.8. Relative displacement between ground and building in Sapanca, Sep. 1999 (Refer to color Photo 15).

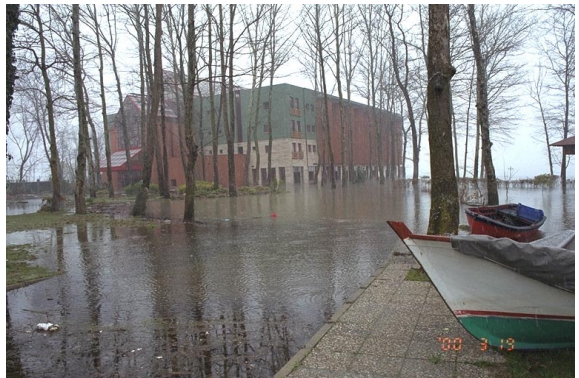
After seven months, the extent of the submerged area was larger than that in Sep. 1999. The extended submerged area is also shown in Figure 2.3.2. The waterfront moved toward inland by several meters. The hotel as shown in Photo 2.3.6 was submerged as shown in Photo 2.3.9. According to comments of local

Photo 2.3.9. Submerged hotel located on the shore of Lake Sapanca, Mar. 2000 (Refer to color Photo 16).

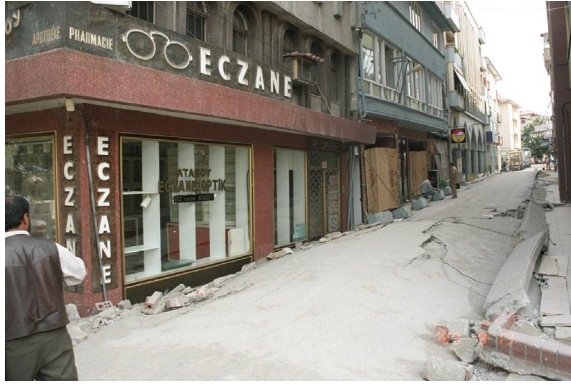
Adapazari is in an alluvium plain formed by River Sakarya on a sedimentary basin, and central part of the city is located to about 50km apart from Black Sea. The most remarkable damage in this district was settlement and inclination of building and up-heave of ground around the building (for example, Photo 2.3.10). Many cracks on pavement were also observed, and they could be caused due to ground deformations. Remarks of sand boils could be observed at a few sites in the district. Besides, at a few sites in this district, shallow ground water level could be confirmed in a trench that might be caused due to relative horizontal displacement between two buildings. Based on the above observations, it is suggested that these ground failures could be due to liquefaction of subsurface soils.

Photo 2.3.10. Up-heave of ground in Adapazari, Sep. 1999.

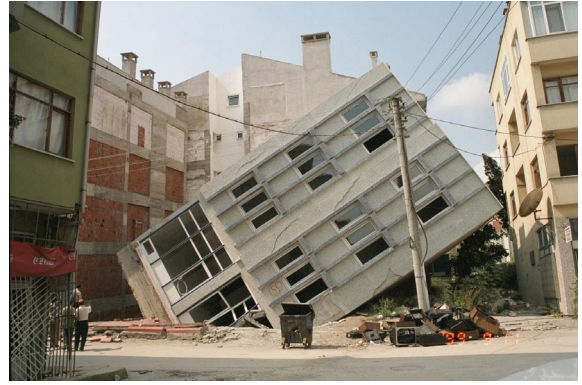
Many buildings, that settled or inclined, had less serious structural damage on their upper structures. Settlements of buildings were more remarkable than the inclinations. However, a few buildings inclined to a large extent. For example, a four-storied reinforced concrete framed building (hereby called Building A), which was located in the northeast side of the crossing of Sakarya Street and Izmit Street shown in Figure 2.3.4, inclined about 60 degree to the short side direction of the building (Photo 2.3.11). There was information that the inclination of the building was about 30 degree immediately after the main shock and it increased up to about 60 degree in the following 10 days. The foundation was a mat type and its embedding depth was about 80 cm. Subsurface soils under the foundation consisted mainly of gravel and sand. The building was located near a borderline between liquefied and nonliquefied areas estimated by the JGS (see Figure 2.3.4).

Photo 2.3.11. Inclination of Building A in Adapazari, Sep. 1999 (Refer to color Photo 12).

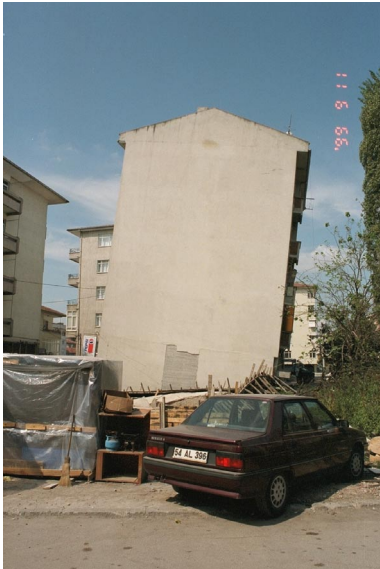
A few buildings, which settled or inclined, had serious damage on their superstructure. For example, a five-storied reinforced concrete framed building (hereby called Building B), which was located in Orta district, the north side of Ankara Street shown in Figure 2.3.4, subsided and inclined, and up-heave of ground around the building were observed as a result (Photo 2.3.12). These ground failures could be due to liquefaction of subsurface soils as stated above. On the other hand, the building was also damaged on the top of a column of 1st floor (Photo 2.3.13). At present, we cannot understand when the column was damaged during the earthquake, before or after soil liquefaction. To understand this matter, more detailed investigations and examinations might be required.

Photo 2.3.12. Inclination of Building B in Adapazari, Sep. 1999.

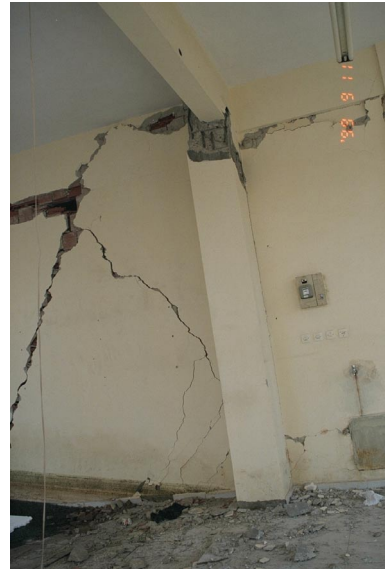
Photo 2.3.13. Damaged column of 1st floor of Building B in Adapazari, Sep. 1999.

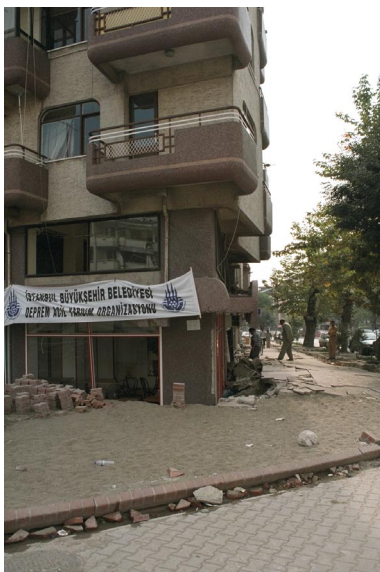
Settlements of the buildings in liquefied area ranged from several ten-centimeters to 1.5m. For example, a six-storied reinforced concrete framed building (hereby called Building C), which was located at the southeast corner of Sakarya Street and Izmit Street shown in Figure 2.3.4, settled by about 1 m without any structural damage on the upper structure (Photo 2.3.14). There was no information regarding foundation of the building. In the northwest side of the crossing of Sakarya Street and Izmit Street, many collapsed buildings were observed. On the other hand, in the southwest side of that crossing, damage to buildings seemed to be slight.

Photo 2.3.14. Settlement of Building C in Adapazari, Sep. 1999.
