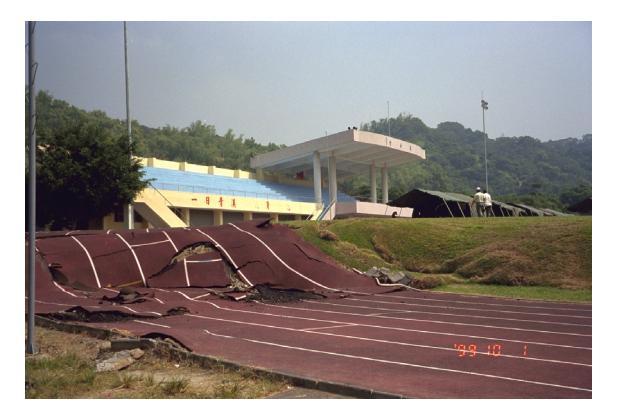
Photo 3. Surface fault break in Wufeng, Sep. 1999.

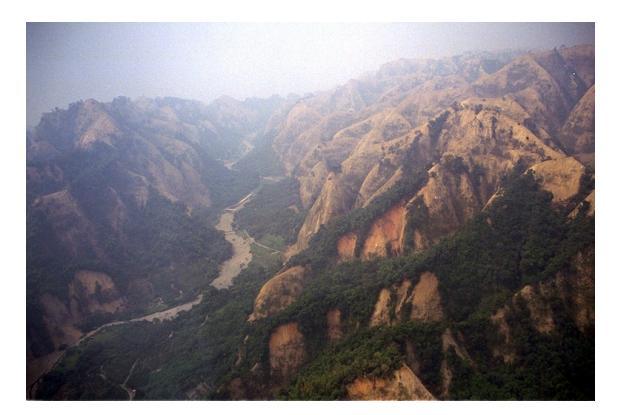
Photo 4. Slope failure in Kouhsing, Sep. 1999.

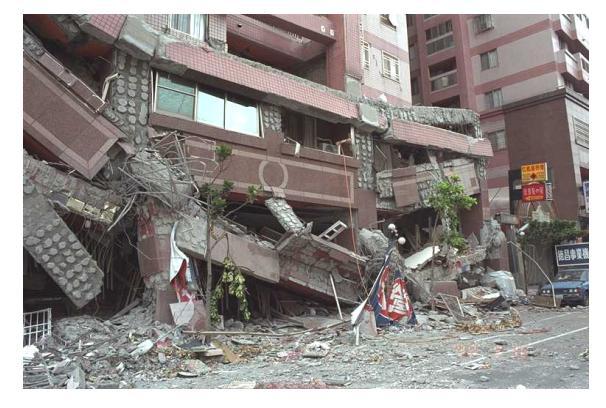
Photo 5. Collapse of high-rise RC buildings in Taichung City, Sep. 1999.

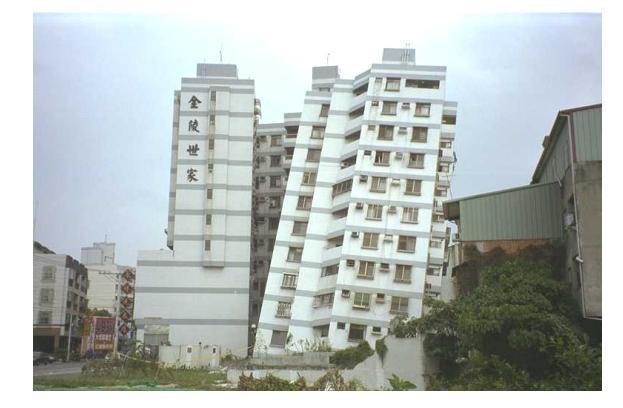
Photo 6. Collapse of high-rise RC buildings in Tali, Sep. 1999.

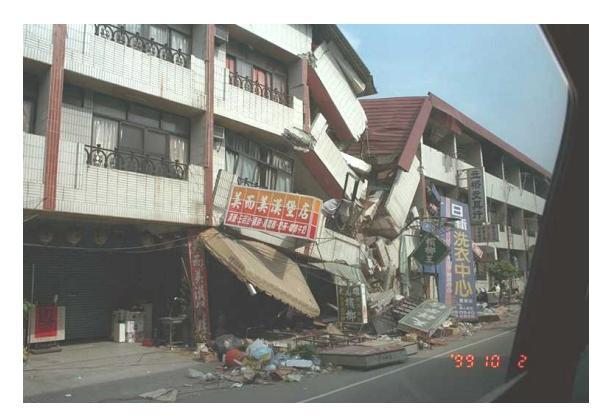
Photo 7. Collapse of 2-4-story RC buildings in Fengyuan, Sep. 1999.

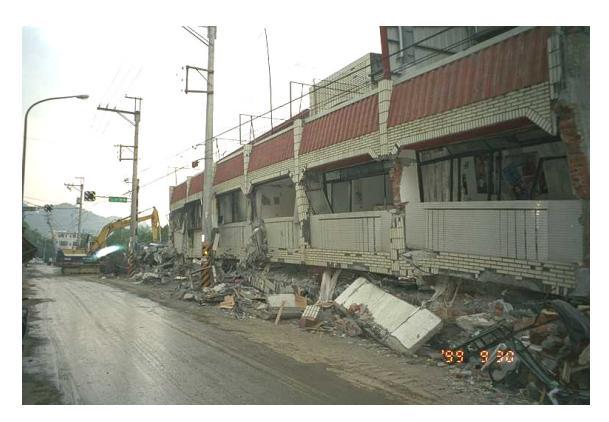
Photo 8. Collapse of 2-4-story RC buildings in Chungliao, Sep. 1999.

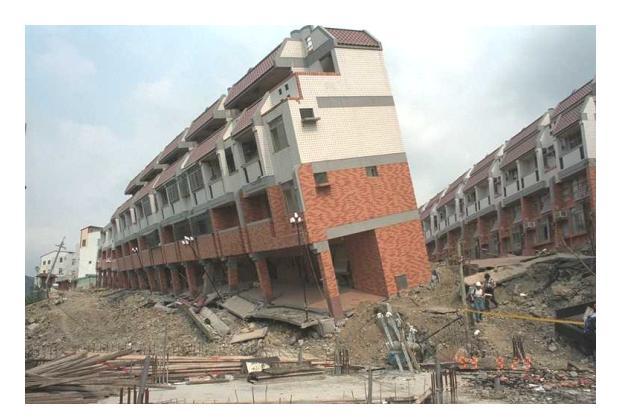
Photo 9. Inclined RC building just on the fault rupture in Fengyuan, Sep. 1999.

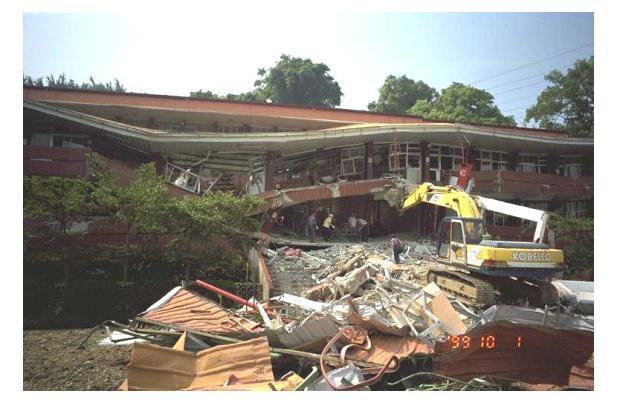
Photo 10. Collapsed buildings due to the surface faulting in Wufeng, Sep. 1999.

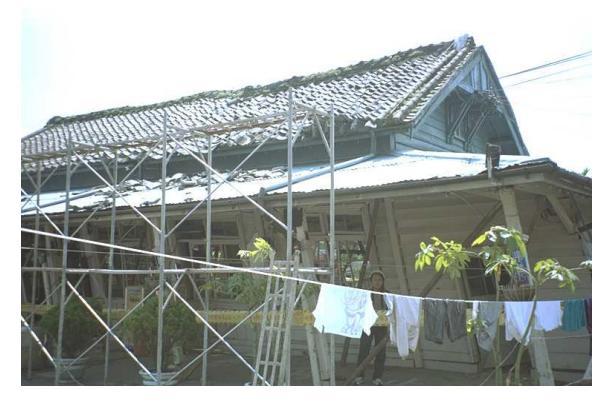
Photo 11. Damages of low-rise non-engineered buildings constructed during Japanese occupation era in Chi-Chi, Sep. 19999.

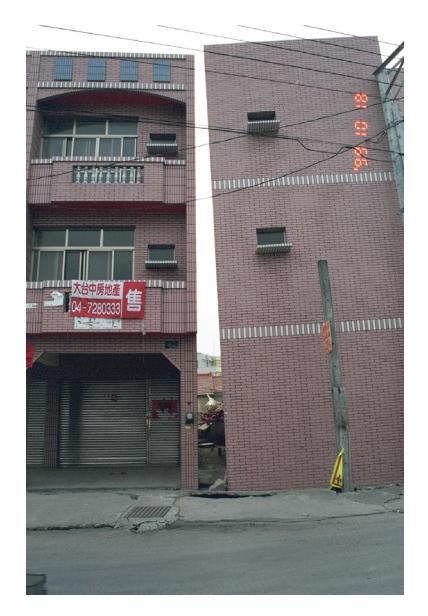
Photo 12. Inclined building in Yuanlin district, Oct. 1999.

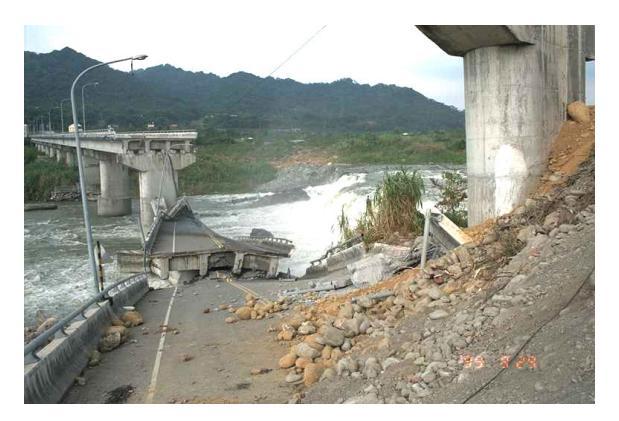
Photo 13. Collapsed Pi-feng Bridge in Fengyuan, Sep. 1999.

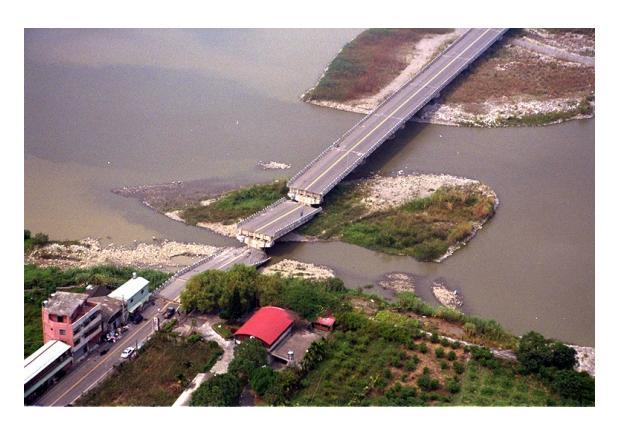
Photo 14. Collapsed Chang-gang Bridge in Shihkang, Sep. 1999.

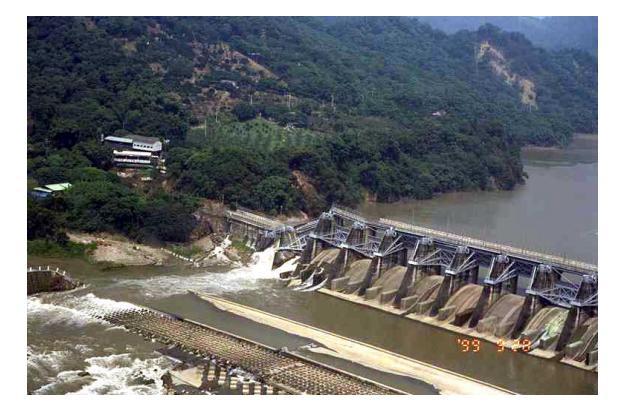
Photo 15. Damaged Shih-kang Dam in Shihkang, Sep. 1999.

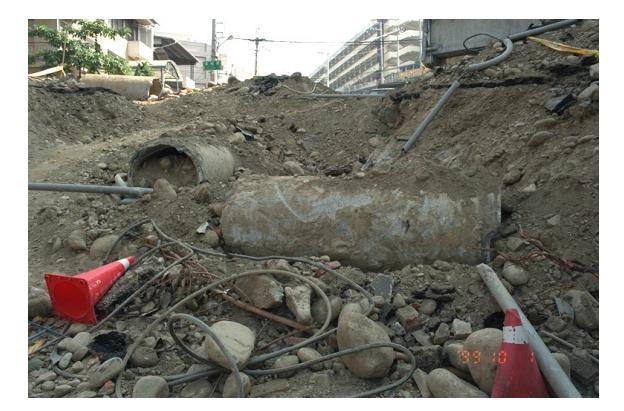
Photo 16. Damaged buried pipelines in Takeng district, Taichung City, Sep. 1999.

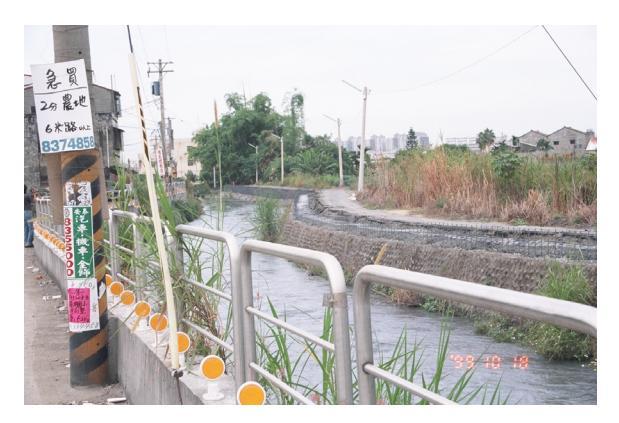
Photo 17. Inclination of telegraph poles and ground deviations at waterway in Yuanlin district, Oct. 1999.

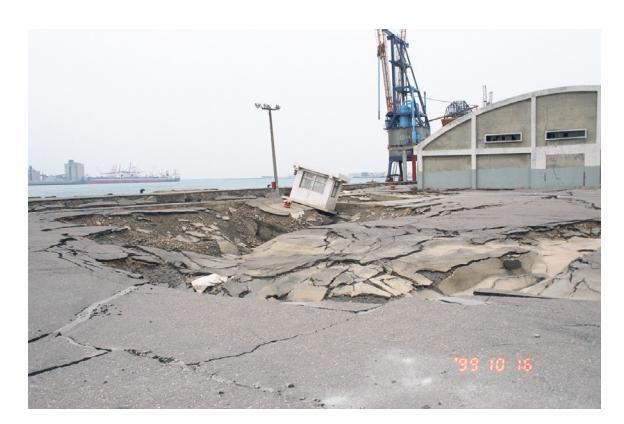
Photo 18. Ground depressions at North terminal in Taichung Harbor, Oct. 1999.
