Microtremor Measurements

Fundamental Periods of R/C Framed and Masonry Buildings

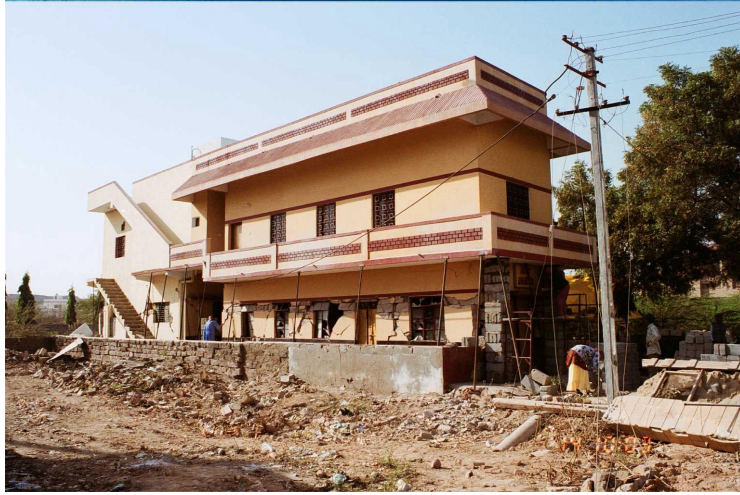
Photo 2. Damaged buildings at which microtremor measurements were performed.

Microtremor measurements were also performed at two buildings for residential use, hereinafter called Buildings A and B (back and front ones in Photo 2, respectively), which are located very close to Site BJ1 in Bhuj. Figure 3 is a schematic map showing locations of the buildings and Site BJ1. These buildings are both two-storied, and Building A has reinforced concrete (R/C) framed structure with infill walls of hollow and/or stone bricks, but B has stone masonry structure. The heights of both buildings are 7.6 m. Building A was completed in 1981, but ground and 1st floors of Building B were in 1988 and 1999, respectively. During the main shock, Building A was slightly damaged but B was heavily damaged (see Photos 2-5). No inclination and subsidence could be observed on both buildings.

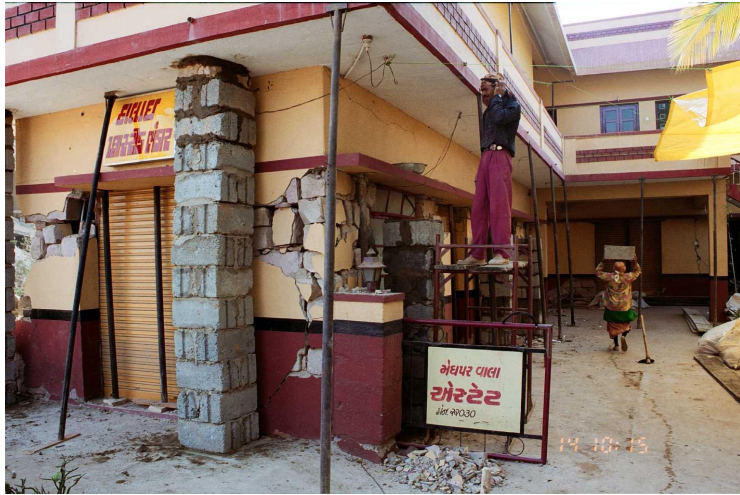
Photo 3. Damage to the buildings (from outside).

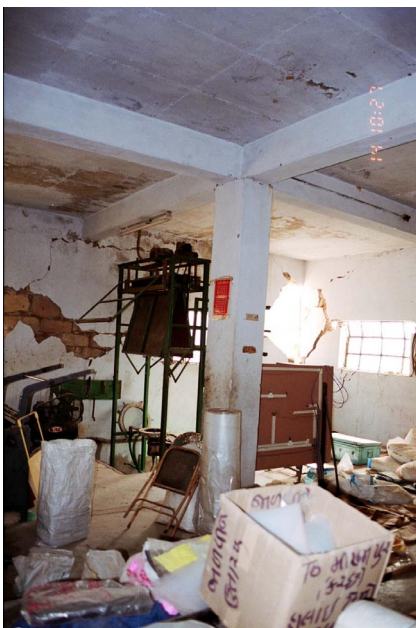
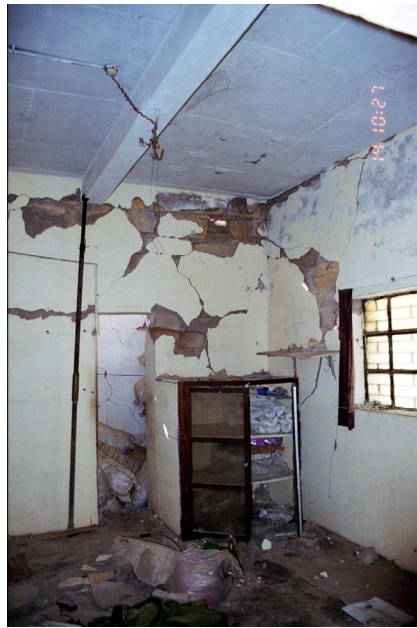
Photos 4 and 5. Damage to the buildings (inside of Building A).

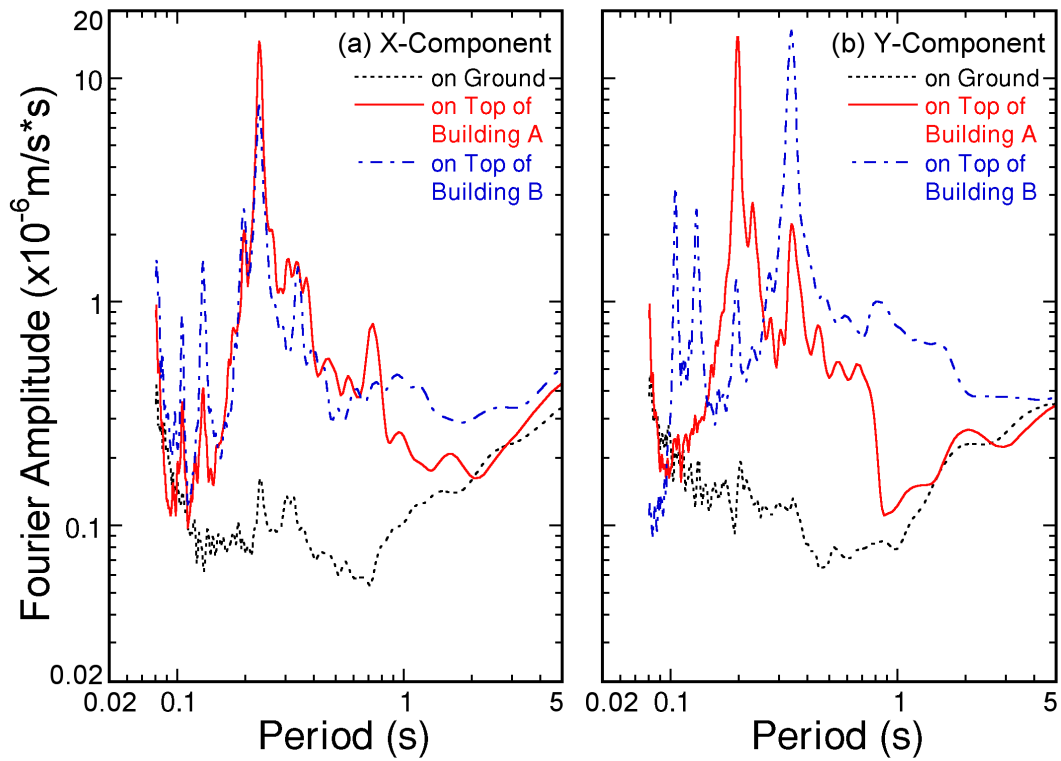
Figures 4(a) and (b) show Fourier amplitude spectra of the observed horizontal X- and Y-component motions at the top and ground floors of the buildings. In the figures, the observed fundamental periods of Building A could be 0.23 s in X-direction and 0.20 s in Y-direction. On the other hand, those of Building B could be 0.23 s in X-direction and 0.34 s in Y-direction.

Figure 4. Fourier amplitude spectra of horizontal X- and Y-component microtremor motions at the top and ground floors of Buildings A and B.

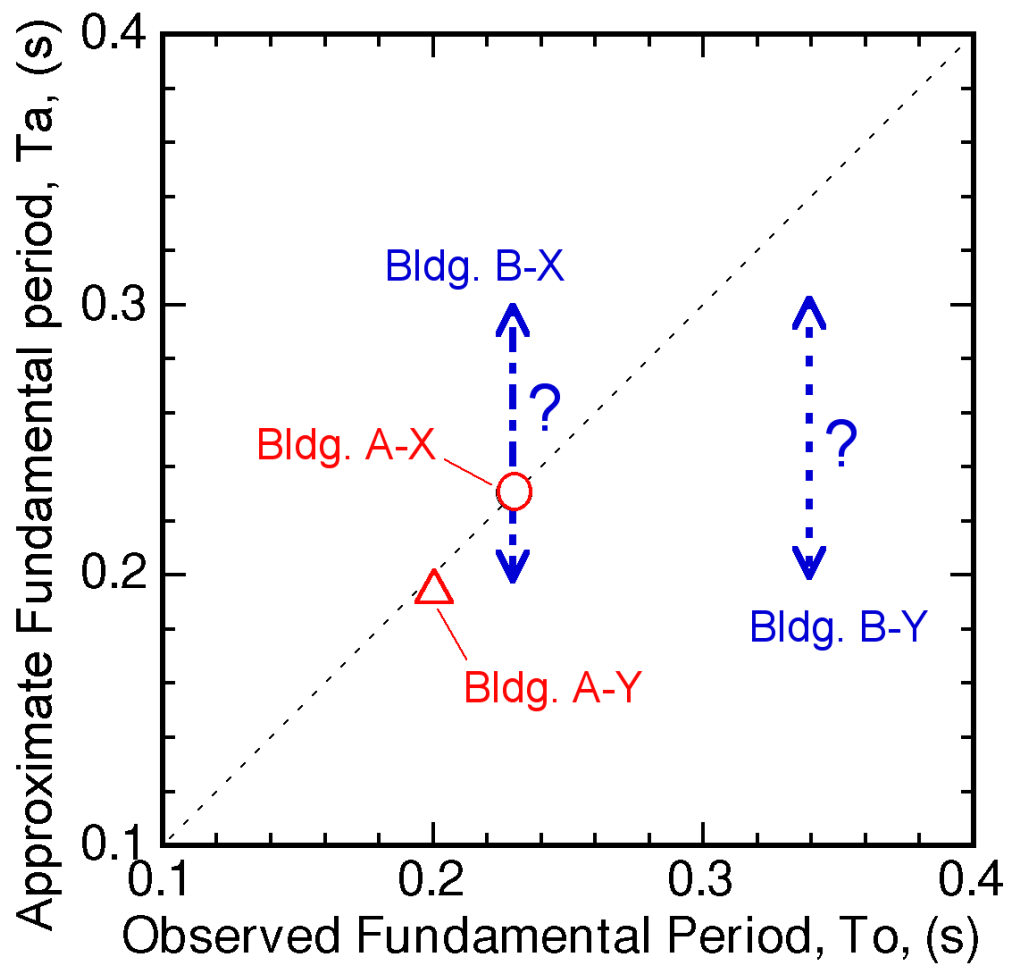
where N is number of stories. Based on Eqs. (1) and (2), approximate fundamental periods of Building A might be 0.23 and 0.20 s in X- and Y-directions, respectively, and those of Building B be about 0.2-0.3 s. Figure 5 shows the relations between observed and approximately computed fundamental periods of the buildings. In Building A, the observed and computed fundamental periods show fairly good agreements, because damage to the building was insignificant. In Building B, on the other hand, the observed fundamental periods are larger than computed ones, especially, by a factor of 1.5 in Y-component, i.e., transverse direction. Assuming that the effects of soil-structure interaction on the observed microtremor motions are insignificant, it is indicated that fundamental period in transverse direction of Building B could change 1.5 times as that before the earthquake because of structural damage. Thus, it is also suggested that maximum response ductility of two-storied masonry building might be about/over 2 during the 2001 Gujarat-India earthquake.

Figure 5. Comparison between observed and approximately computed fundamental periods of Buildings A and B.
