4. Damage Detection from the Air and Space

4.1 Extraction of the Areas of Slope Failure using SPOT Images

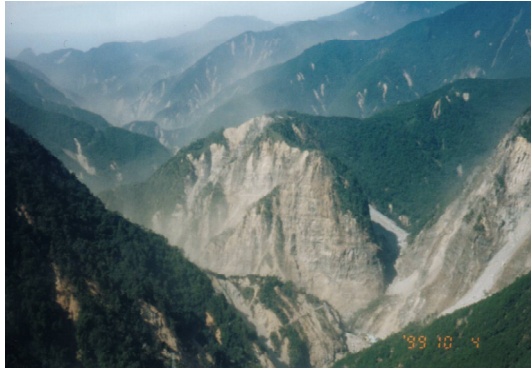
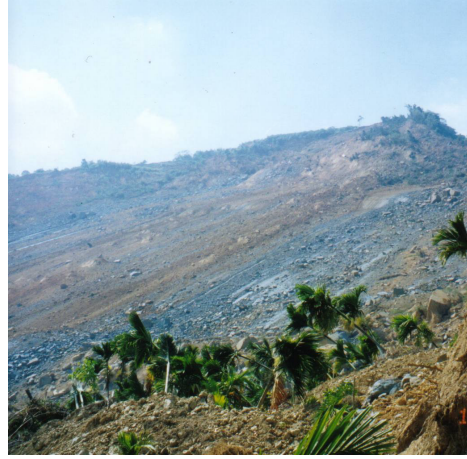
(a) Gwu-Guan

(b) Jio-Fun-Ell-Shan

(c) Hoyen-Shan

Figure 4.1.1. Slope failures in mountainous areas (The Japanese Geotechnical Society, 2000).

Large-scale slope failures occurred in the forest covered mountainous districts such as Gwu-Guan, Jio-Fun-Ell-Shan and Hoyen-Shan as shown in Figures 4.1.1 (The Japanese Geotechnical Society, 2000). The slope failures changed the vegetation areas into bare grounds. Although the application of the normalized vegetation index ($NDVI$), using a multi-spectral image to evaluate a vegetation area, is a general approach, we examined the possibility of panchromatic images, which contain higher ground resolution than multi-spectral images, as a tool to detect surface changes. The data used in this investigation were SPOT/HRV panchromatic images taken on June 24th, 1999 as a pre-event image, and on September 27th, 1999 (6 days after the event) as a post-event image. The ground resolution of these images is approximately 10m and the wavelength captured by this sensor is in a visible light range. Figures 4.1.2 shows the pre-event image and post-event one, respectively.

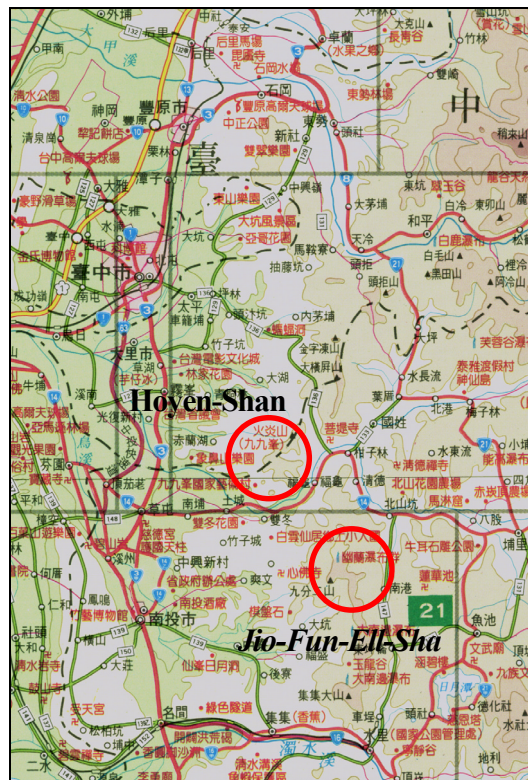
Figure 4.1.4. Location of huge-scale slope failures (The Japanese Geotechnical Society, 2000).

The color from blue to red was allocated to the pixels that have the ND from small to big. Black colored areas indicate the areas of cloud. In this figure, yellow to red colored areas distributed in the mountainous region are relatively in good agreement with the large-scale slope failures shown in Figure 4.1.4 by JGS (2000). Generally, the DN in the visible range for vegetation areas is smaller in comparison with that for bare grounds. It is conceivable that the DN was raised in the areas of the slope failures due to the exposure of soil surface after the earthquake. The areas with color from yellow to red can be seen around the clouds because the removal of the cloud areas was insufficient. However, other areas, dotted in the mountainous region, could be several small slope failures occurred due to the earthquake. We need to confirm the validity of this result by a detailed field survey in the further.
