## 2.5 Liquefaction

### 2.5.1 Outline of Surveys

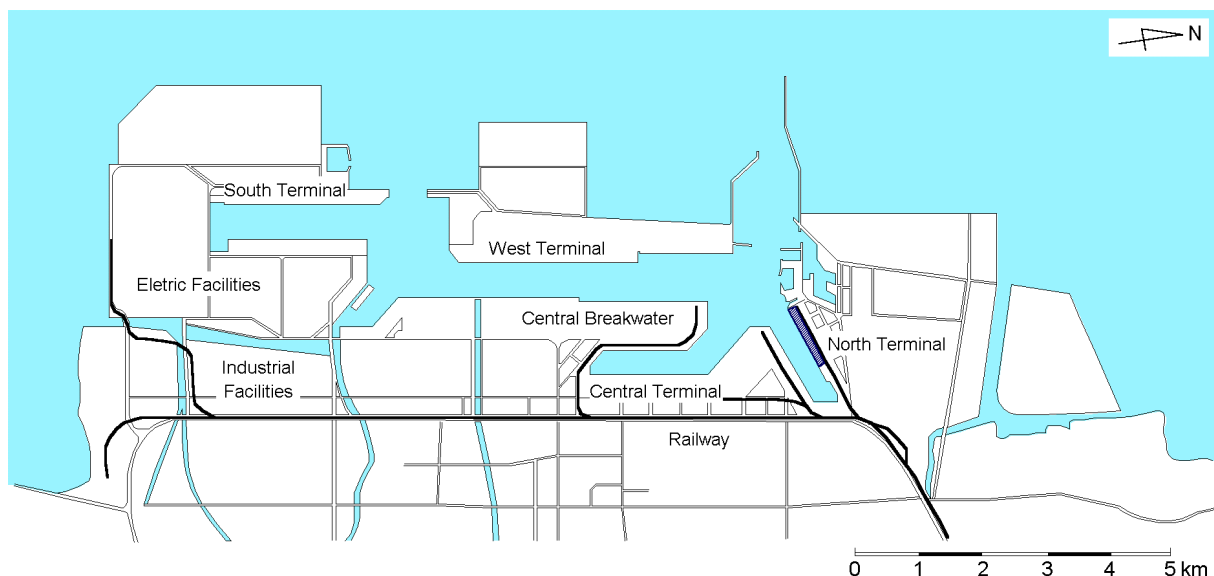
Figure 2.5.1. Schematic plan of Taichung Harbor.

Figure 2.5.1 shows a schematic plan of Taichung Harbor. This harbor is located on the reclaimed land. In the harbor, remarkable ground failures were observed at North terminal only. Figure 2.5.2 shows a schematic map of North terminal in Taichung Harbor, and also shows the investigated area. North terminal has five wharfs (No. 1-4, and 4A), which had been built in 1973 and completed in 1976.

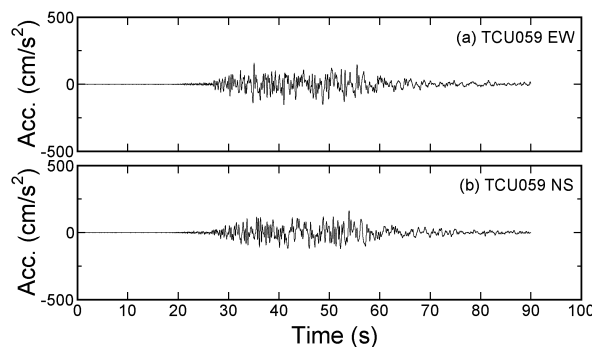
Figure 2.5.6. Acceleration time series recorded at TCU059 during the main shock (Lee *et al.*, 1999).

In Taiwan, an intense strong motion array called TSMIP has been installed island-wide. Near Taichung Harbor, there are several seismograph stations in near distance. Among them, the closest one is the station located at the elementary school of Chingshui (Station Code: TCU059, on ground), where is about 4.7km southeast of the harbor. During the main shock, the accelerations of ground motions at the site were successfully recorded and are available tentatively (Lee *et al.*, 1999). Figures 2.5.6(a) and (b) show the acceleration time series of the two orthogonal horizontal motions (EW and NS components) recorded at TCU059. Peak ground accelerations (PGA) of the both motions are about  $160\text{cm/s}^2$ , and their durations are about 30s long. Peak ground velocities and displacements (PGV and PGD) estimated by integrating the acceleration time series could

be about 50cm/s and 40cm, respectively, for the both horizontal motions. In particular, the values of PGD are larger than those estimated from the acceleration records in Kobe, Japan, during the 1995 Hyogo-ken Nambu earthquake. From now, many studies on mechanism of damage to Taichung Harbor would be conducted using the damage information, soil profile data, and recorded ground motions. A study on this matter, for example, is performed in Chapter 5 of this report.

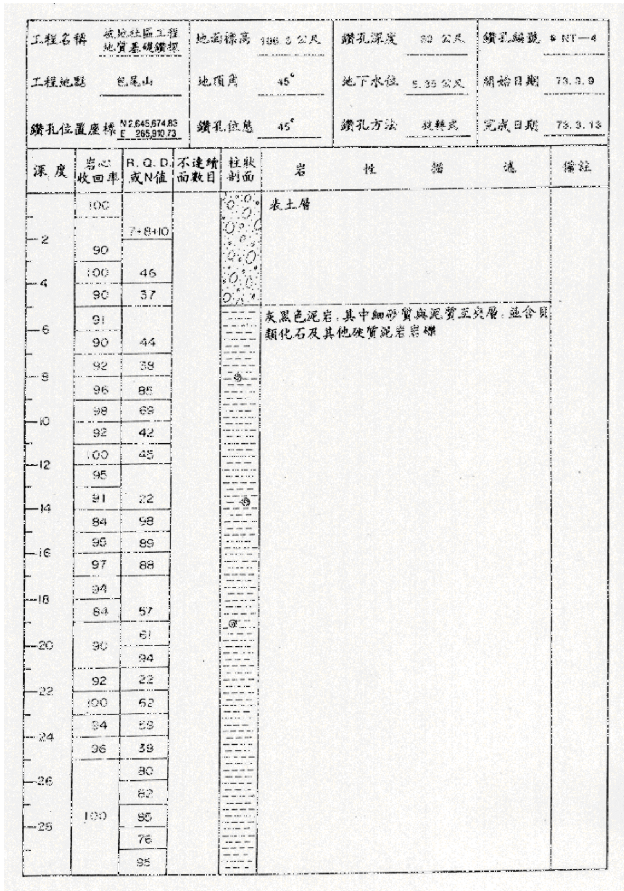
Figure 2.5.9. Soil profile at Site C in Nantou city (Central Geological Survey, Taiwan, 1995).

Figure 2.5.9 shows a boring log at Site C shown in Figure 2.5.7 (Central Geological Survey, Taiwan, 1995), where is about 1km southeast of Building B. Any ground failures and remarks of soil liquefaction has not been reported at Site C. In Figure 2.5.9, SPT-N values up to a depth of 2m are about 10, and those at a depth over 2m range over 40, and the level of water table is about 5m depth. These information suggest that subsurface soils at Site C could not be liquefied during the earthquake, in which the values of PGA and PGV were  $400\text{cm/s}^2$  and  $60\text{cm/s}$  at most, respectively. Based on the above suggestions, it is indicated that response characteristics of

subsurface soils during earthquakes could vary considerably among Sites A, B, and C.
