4.2 Automated Damage Detection using Aerial HDTV

4.2.1 Method of Automated Damage Detection for Kobe Area

4.2.2 Application to the Chi-Chi earthquake

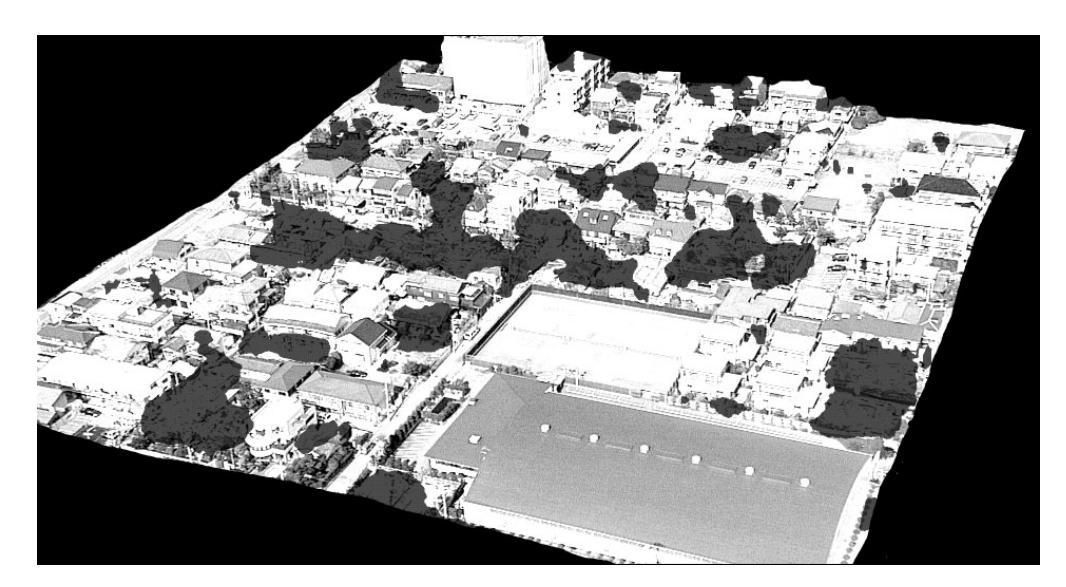
Figure 4.2.1. Collapsed buildings extracted from the area of Nishinomiya City by texture analysis for the identified pixels by image processing of HDTV images (Hasegawa et al., 2000b).

An automated detection method for building damage was investigated using the aerial HDTV images taken after the Kobe earthquake (Hasegawa et al., 2000b). The degree of building damage by a field survey was correlated with color indices and edge intensity from the aerial images by image processing. The characteristics of damage to wooden buildings were defined based on hue, saturation, brightness and edge intensity. Using the threshold values of these parameters, the typical areas were classified into damaged and undamaged pixels. A texture analysis was then introduced to these pixels and the damaged buildings were identified (Figure 4.2.1). The extracted damage distribution by the proposed method agreed well with the ground truth data and the visual inspection of the HDTV images (Figure 4.2.2). The steps of the automated detection method are followings:

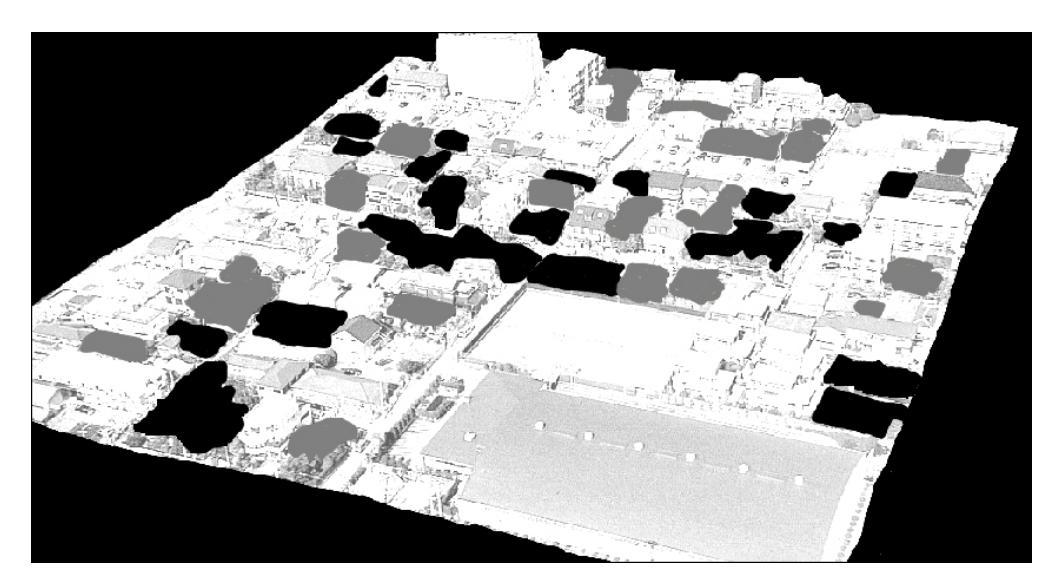
Figure 4.2.2. Collapsed (black) and heavily damaged (gray) buildings in the area of Nishinomiya City detected by a field survey and a visual inspection of HDTV images (Hasegawa et al., 2000b).

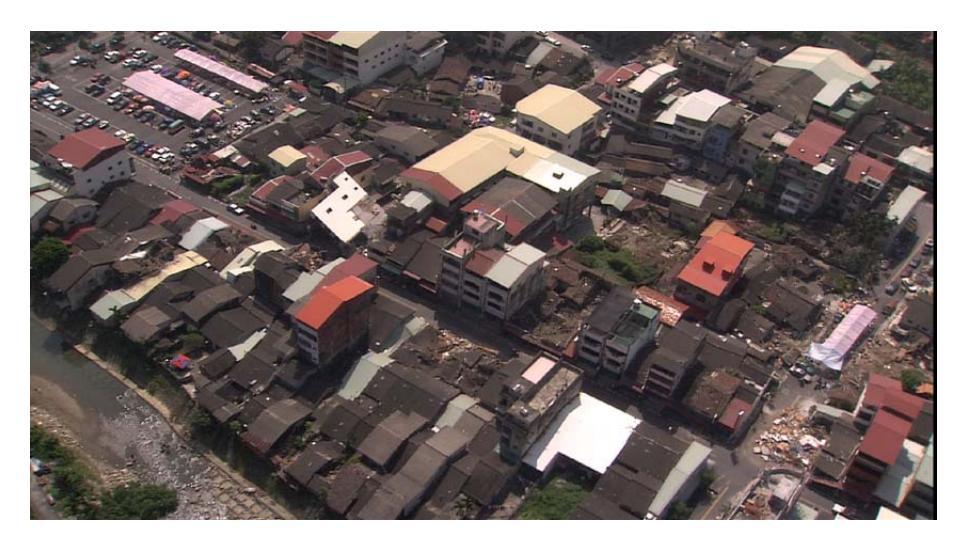
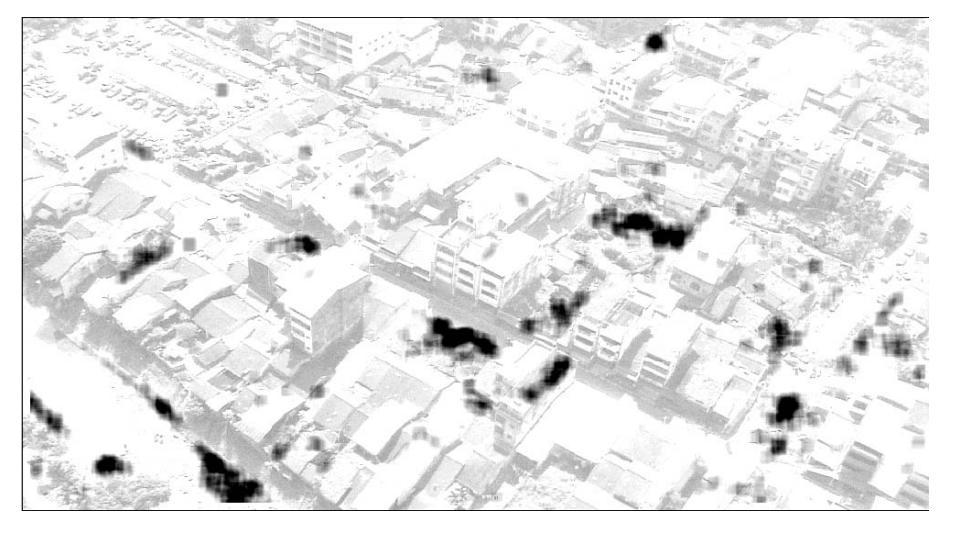
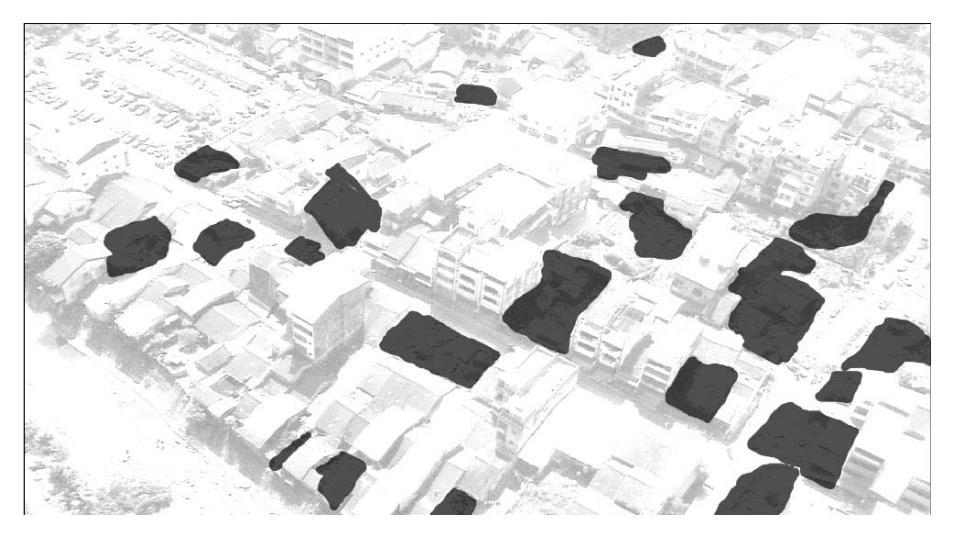
(b) Building damage distribution obtained by the automated detection

(c) Building damage distribution obtained by the visual inspection Figure 4.2.3. Building damage detection based on aerial HDTV image for Chi-Chi area (1).

The proposed automated detection method for building damage was applied to the aerial HDTV images taken after the 1999 Chi-Chi, Taiwan earthquake. For the snapshots of the hard-hit areas from a helicopter, the automated damage detection was conducted and the results (Figures 4.2.3(b) - 4.2.6(b)) were compared with those of visual inspection of the images in Figures 4.2.3(c) - 4.2.6(c). These comparisons indicated that the identified areas by the automated detection method almost agree with those by the visual inspection. But it should be pointed out that, in Taiwan, the roofs of wooden houses are different from those in Kobe area. Hence, even for visual inspection, damage detection for wooden buildings was more difficult in Taiwan. Considering the difference in the

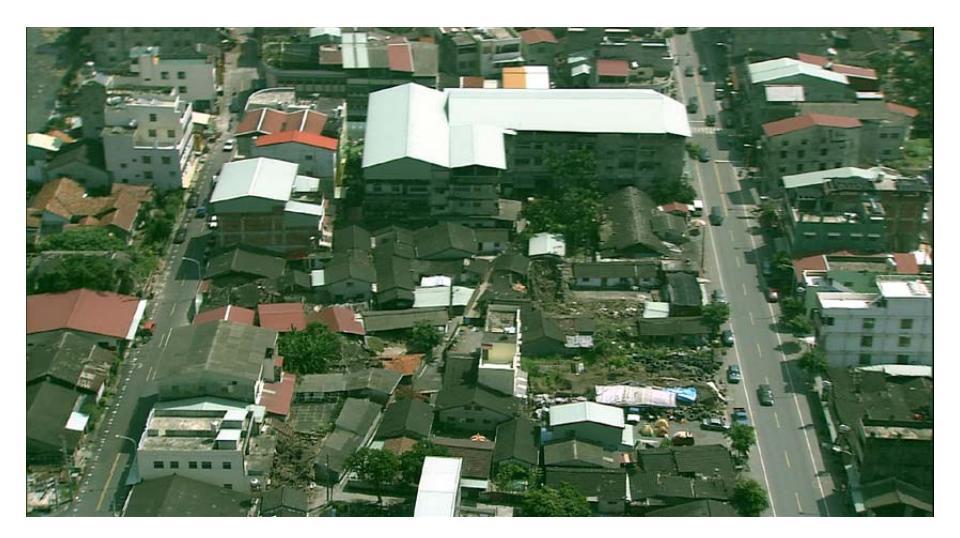
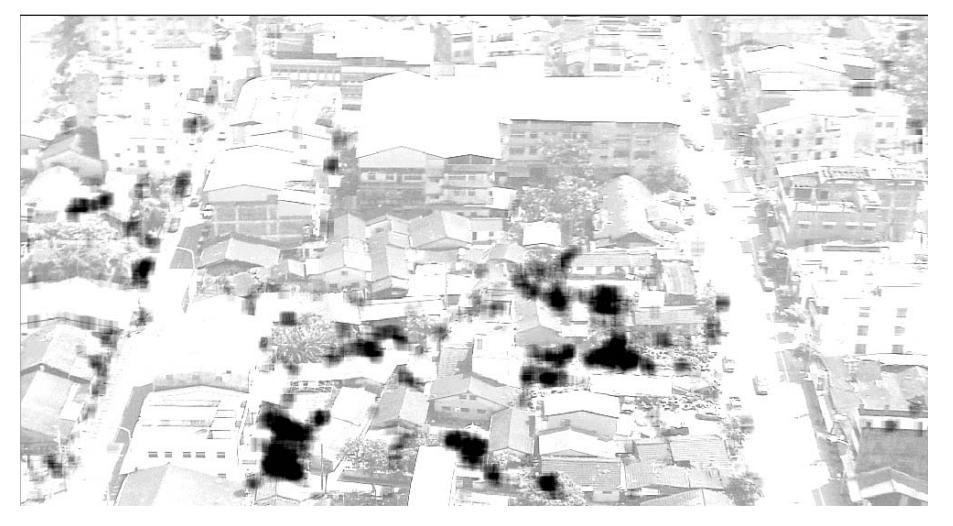
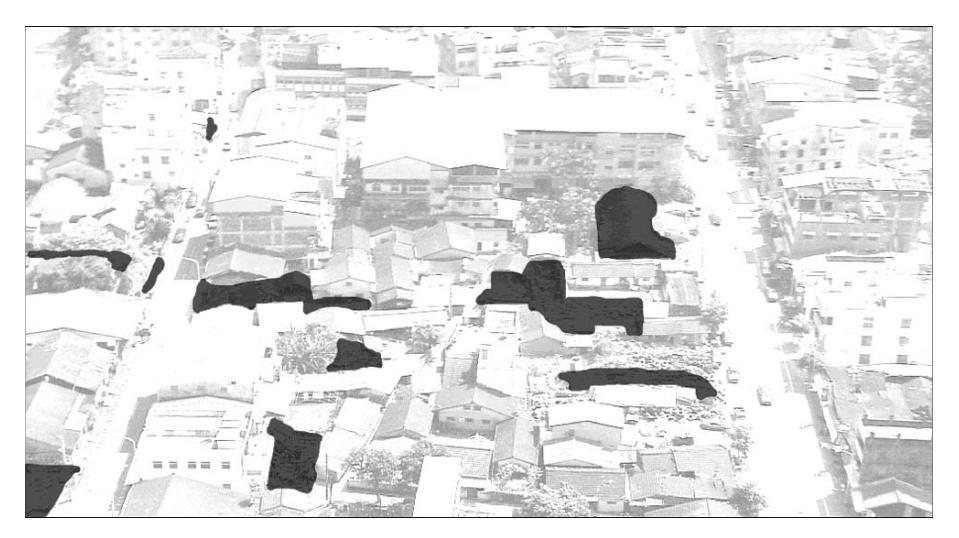
(b) Building damage distribution obtained by the automated detection

(c) Building damage distribution obtained by the visual inspection Figure 4.2.4. Building damage detection based on aerial HDTV image for Chi-Chi area (2).

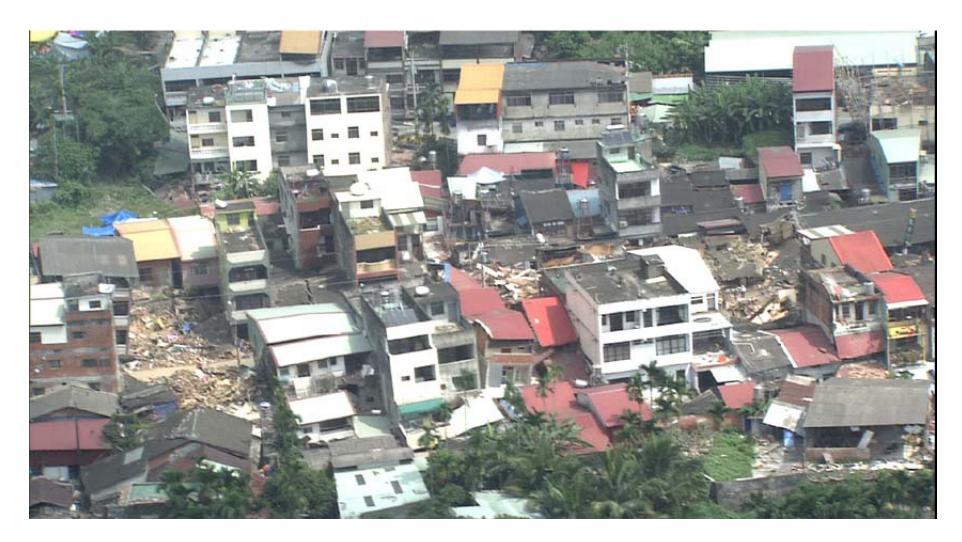
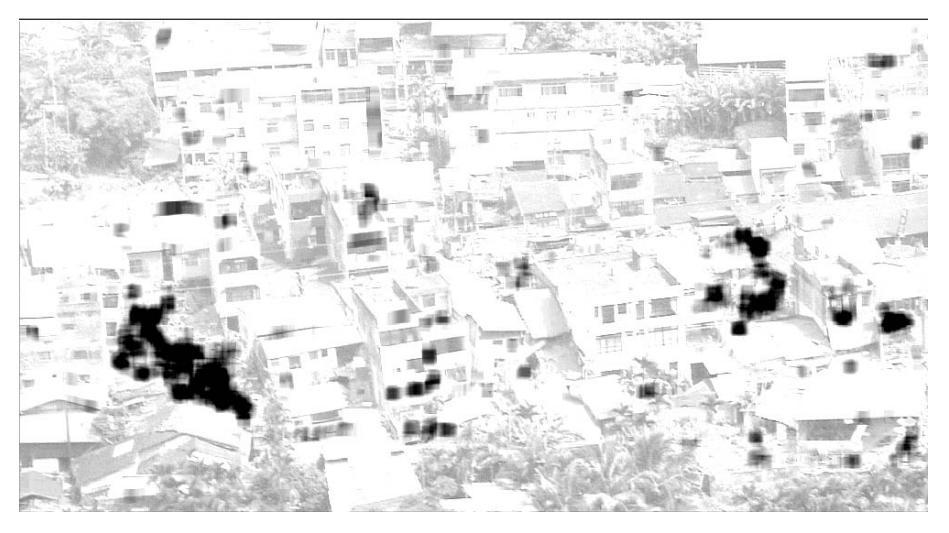
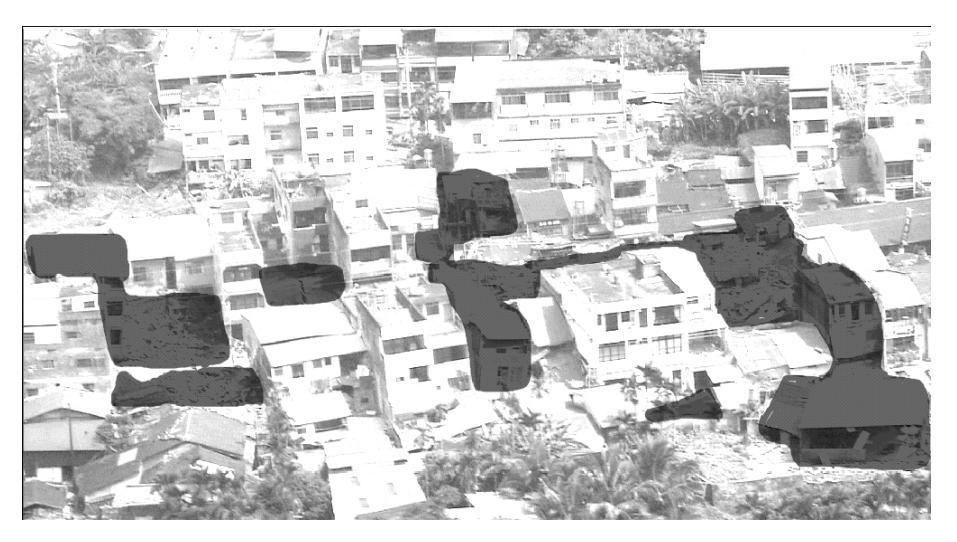
(b) Building damage distribution obtained by the automated detection

(c) Building damage distribution obtained by the visual inspection Figure 4.2.5. Building damage detection based on aerial HDTV image for Chungliao area (1) (Refer to color figure 6).

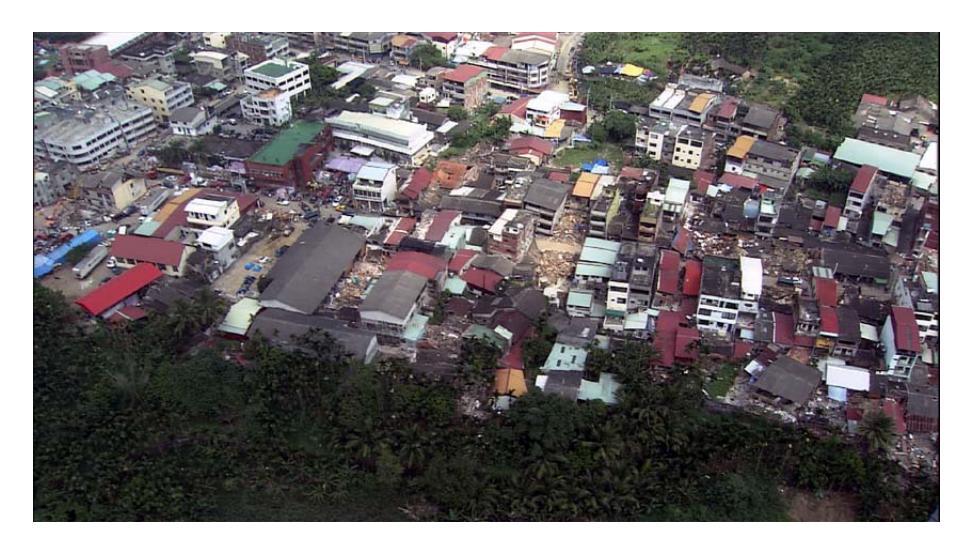
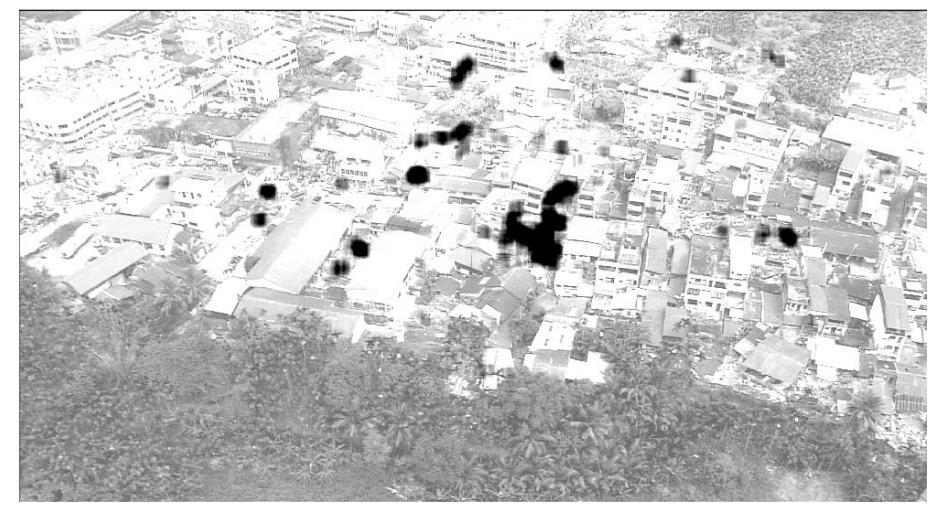
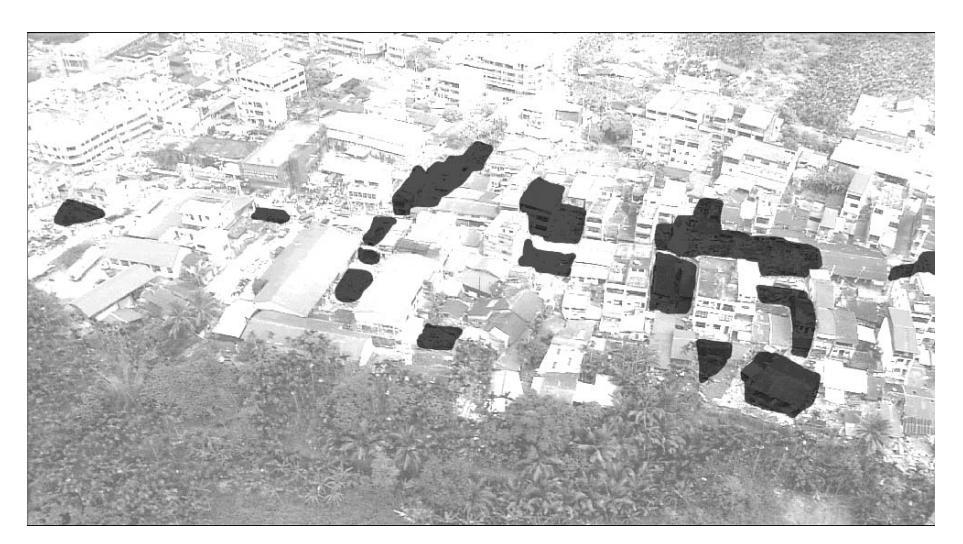
(b) Building damage distribution obtained by the automated detection

(c) Building damage distribution obtained by the visual inspection Figure 4.2.6. Building damage detection based on aerial HDTV image for Chungliao area (2).
